# FUNCTIONAL SERVICING & STORMWATER MANAGEMENT REPORT

PROPOSED RESIDENTIAL COMMON ELEMENT DEVELOPMENT
900 MISSISSAUGA HEIGHTS DRIVE
CITY FILE No. OZ/OPA 22-1
904 MISSISSAUGA HEIGHTS DRIVE
CITY FILE No. OZ 21-13 W7

FILE No. 219-M20

**APRIL 19, 2023**

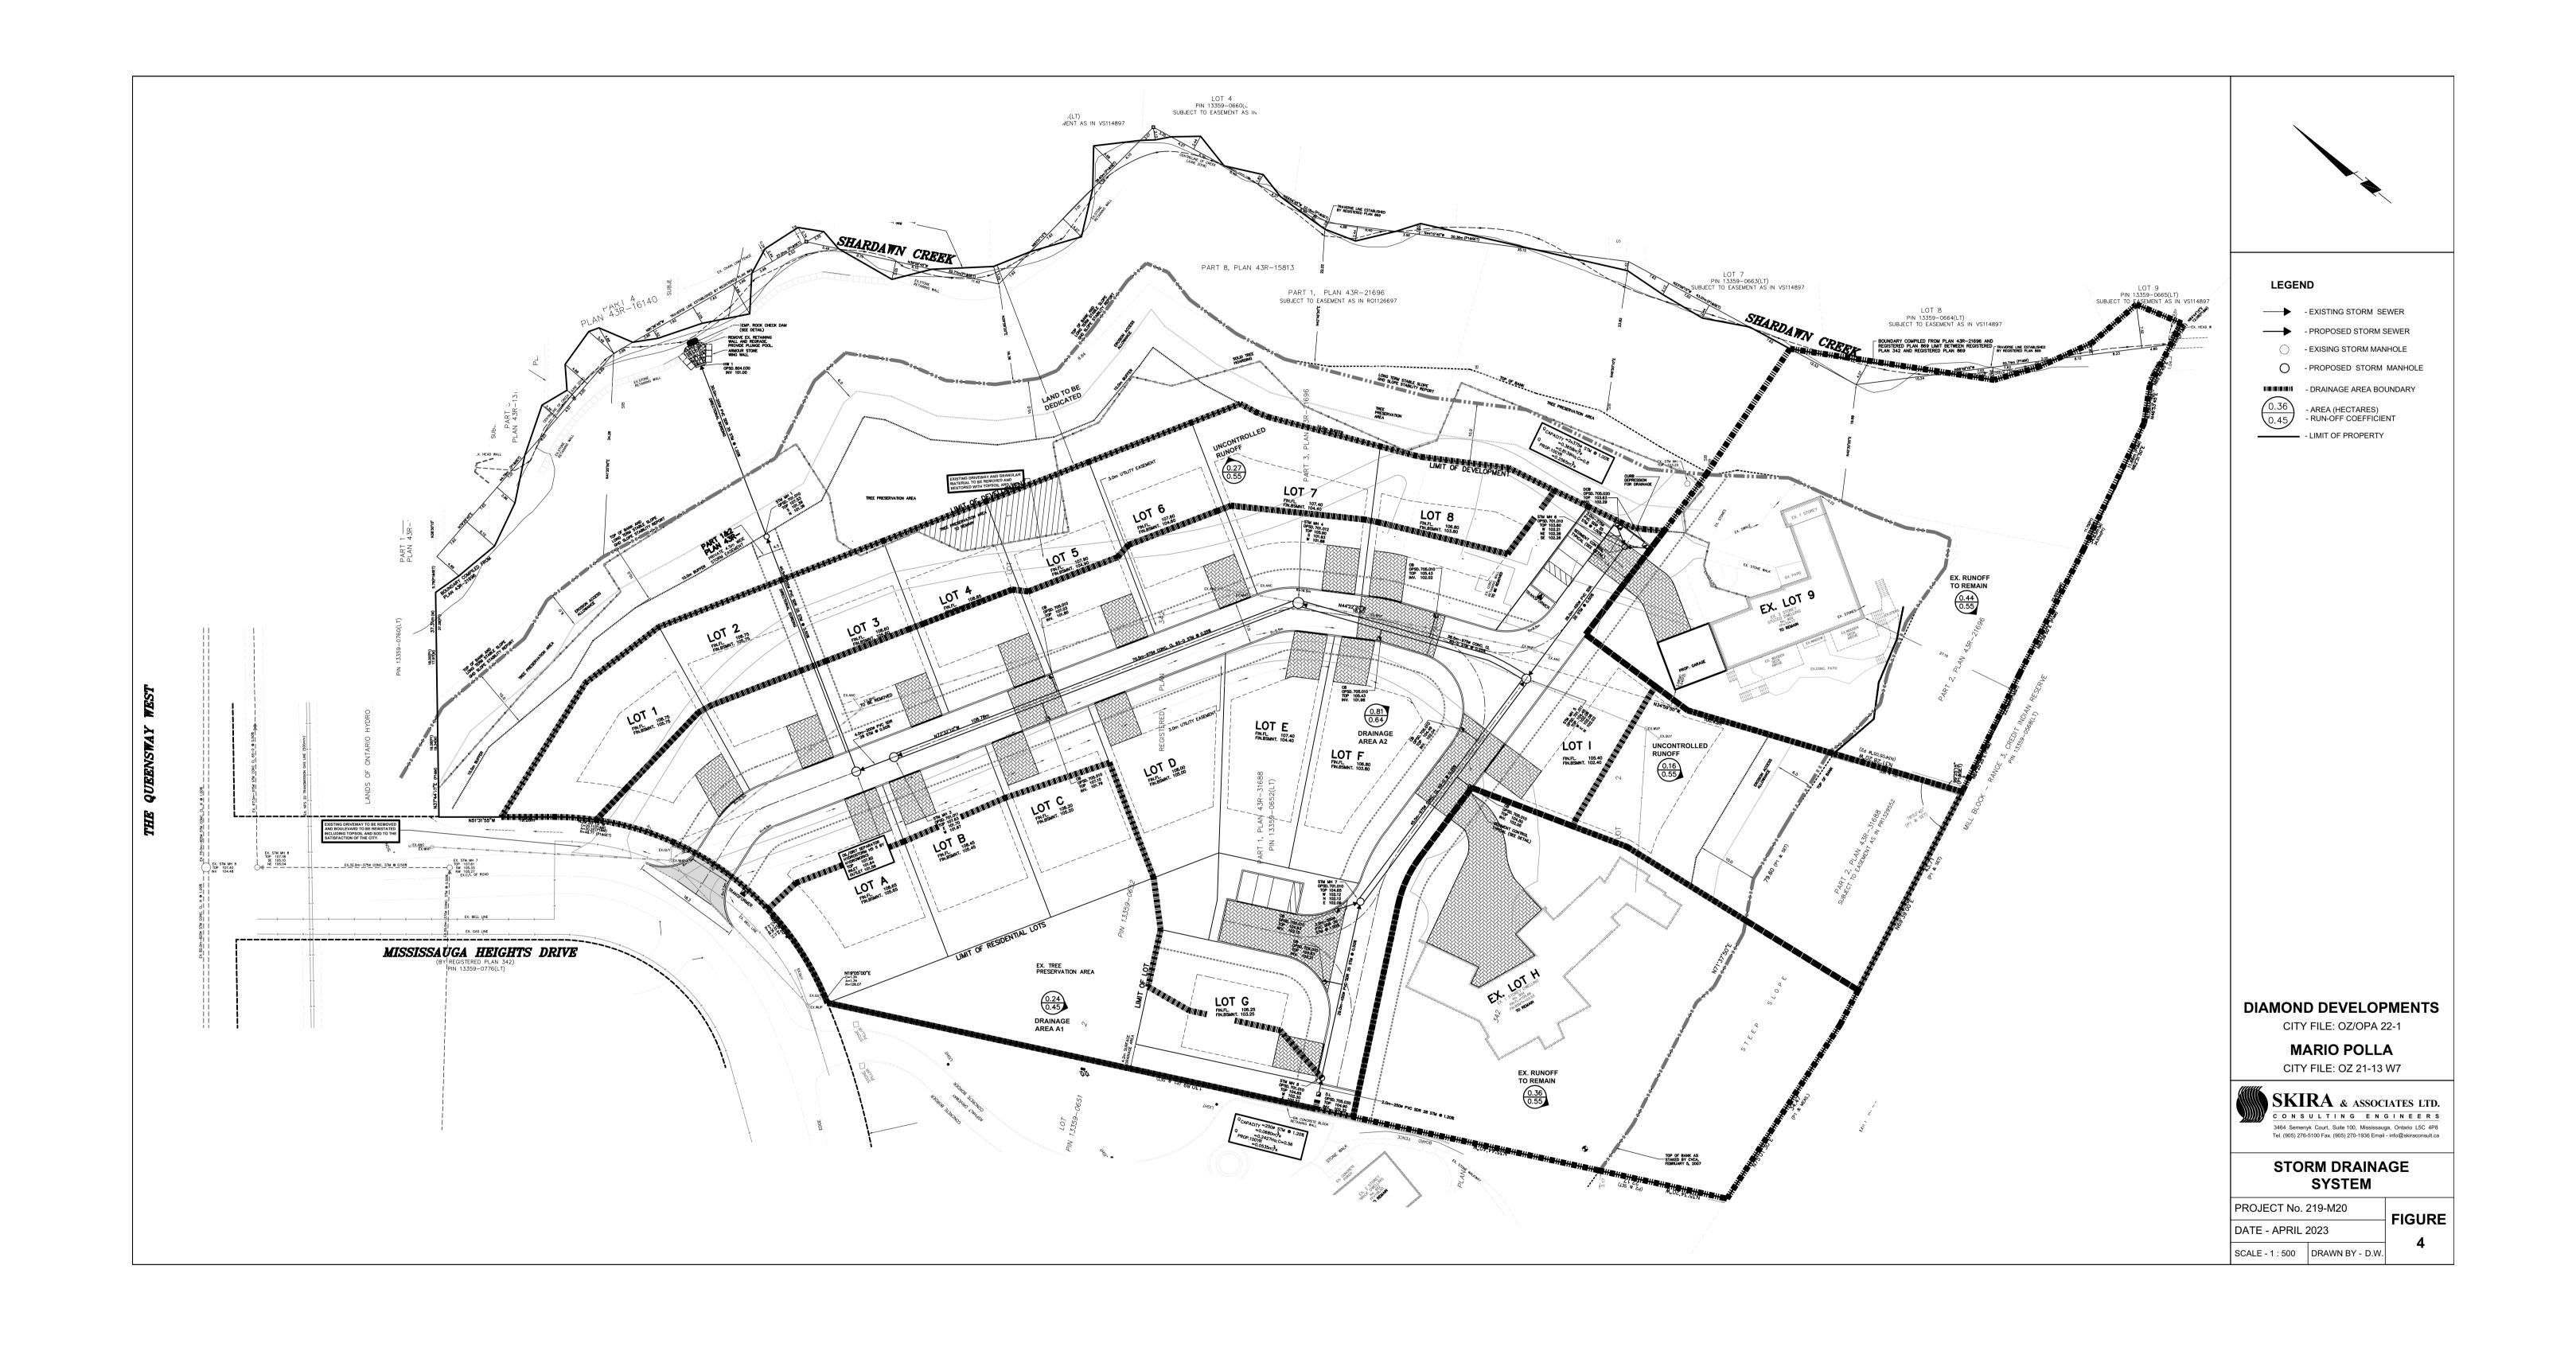
The controlled runoff area (1.0566ha) will be further divided into two areas, drainage area A1 (0.2427ha) and drainage area A2 (0.8139ha). Refer to *Figure 4* for the storm drainage plan. Based on the site characteristics, the weighted runoff coefficient is calculated below:

Runoff from the drainage area A1 will be captured at the proposed ditch inlet along the south boundary of the site. Runoff from the drainage area A2 will be captured at the proposed double catchbasins along the north boundary of the site. Runoff captured will be conveyed through the proposed storm leads. The capacities of the proposed storm leads are as follows:

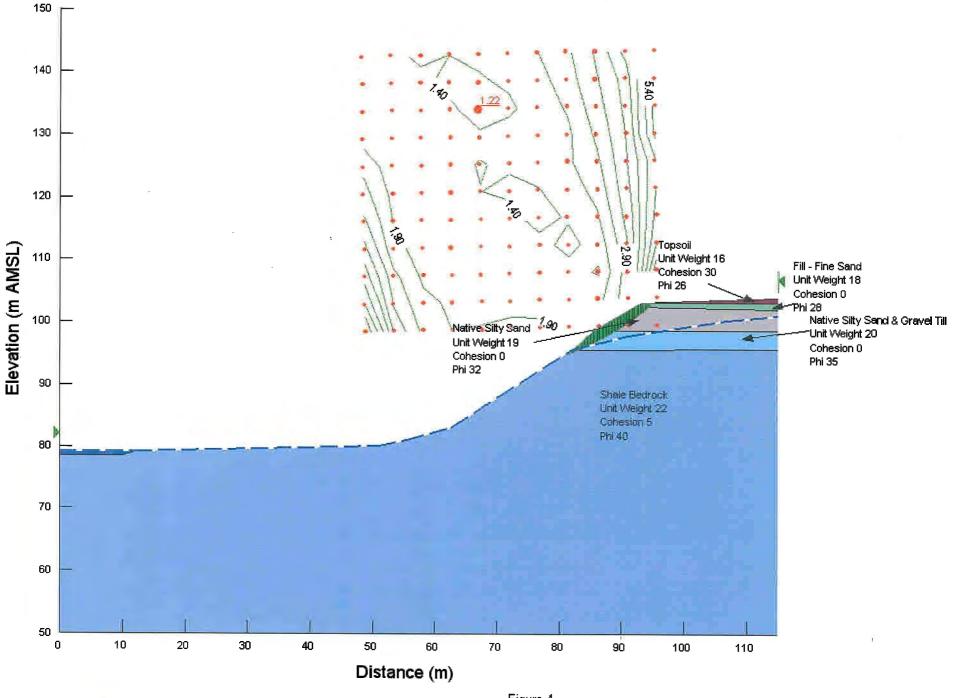
Figure 4 T040022-A1 Slope Stability Analyses Section A-A - Shallow Failure Proposed Residential Dwelling and Guesthouse 904 Mississauga Heights Road, Ontario

Section	Overall Slope Inclination		FOS against Shallow Slope Failure	FOS against Intermediate/Deep Seated Slope Failure		
	Upper:	2:1		•		
A-A	Central	1.3:1	1.22	1.54		
	Lower:	3:1	=:

It is noted that the slope face comprises of tall mature trees and shrubs. No significant evidence of erosion, sloughing, or instability were observed on the slope face and there were no tension cracks observed parallel to the slope crest. Also, no wet areas or evidence of water seepage was observed emanating from the slope. The slope face was observed to be dry. Based on our observations, experience and analysis, the existing slope represented by Section A-A is considered safe against shallow slope failure.

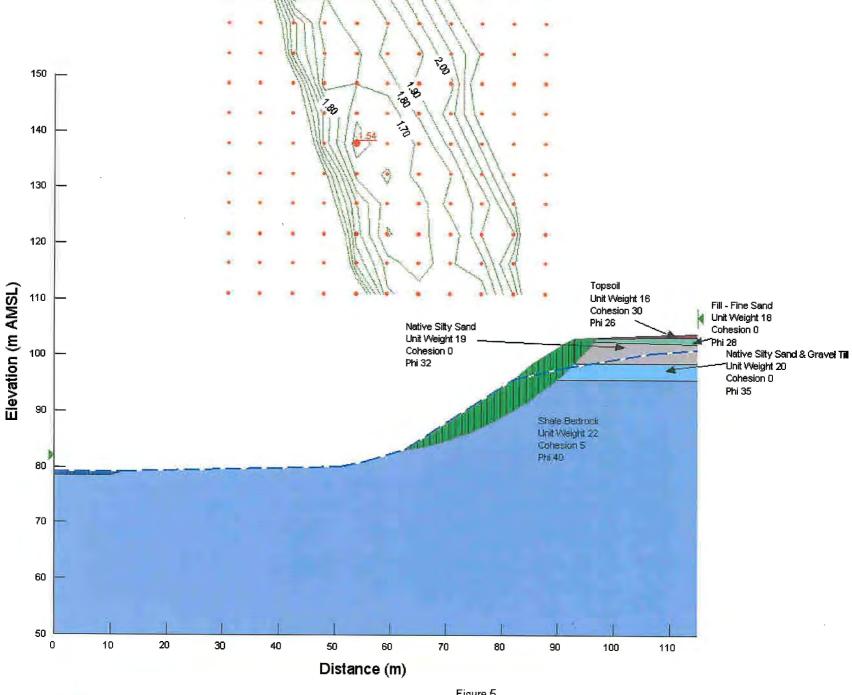
Figure 5 T040022-A1 Slope Stability Analyses Section A-A - Deep Failure Proposed Residential Dwelling and Guesthouse 904 Mississauga Heights Road, Ontario

Based on the results of our engineering analyses, the existing slope represented by Section A-A is considered to be safe against intermediate and deep seated failure (FOS > 1.5).

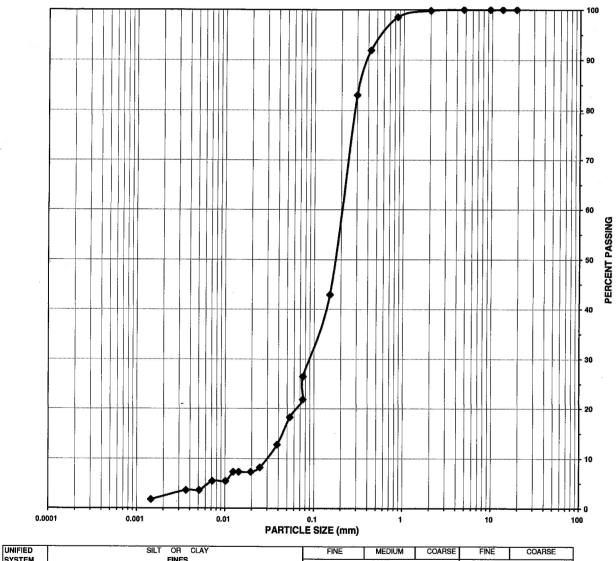
### **GRAIN SIZE DISTRIBUTION**

SOIL COMPOSITION: Sand 73%, Silt 24%, Clay 3%

Laboratory testing consisted of moisture content tests on all recovered samples and gradation analysis on two select samples obtained from the boreholes. The moisture content results are presented on the borehole logs and the grain size results are attached in Appendix B.

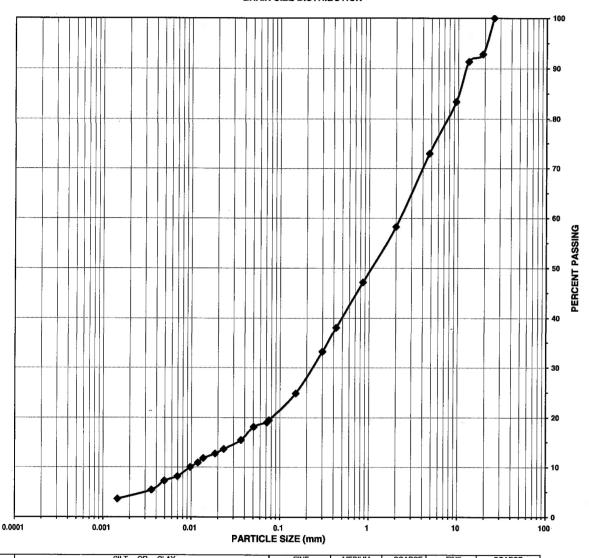
### **GRAIN SIZE DISTRIBUTION**

Silt 15%, Clay 4%

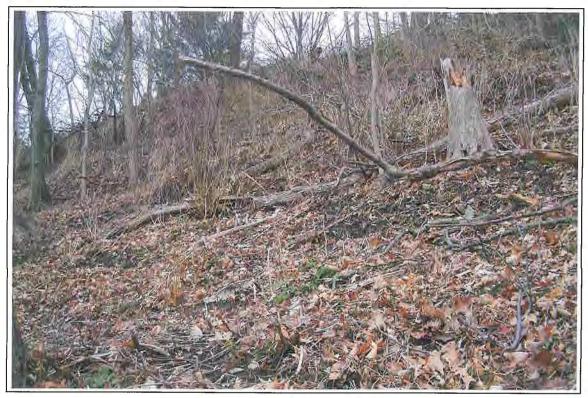
Photo No 1 - Mid Section of the Slope Cross Section

Based on our field observations, the slope face comprises of tall mature trees and shrubs. No significant evidence of erosion, sloughing, or instability were observed on the slope face and there were no tension cracks observed parallel to the slope crest. Also, no wet areas or evidence of water seepage was observed emanating from the slope. The slope face was observed to be dry. Also, there was no evidence of surface erosion associated with the surface water or runoff flow.

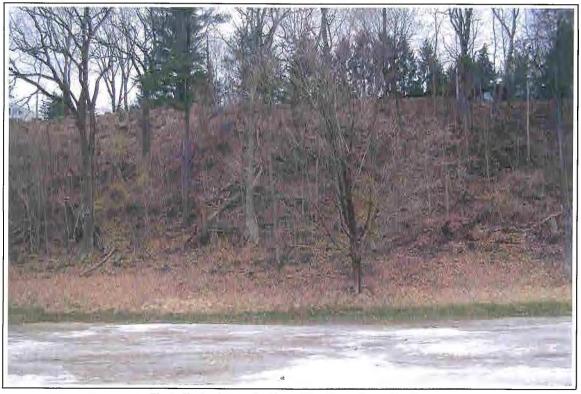
Photo No 2 – Lower Section of the Slope Cross Section

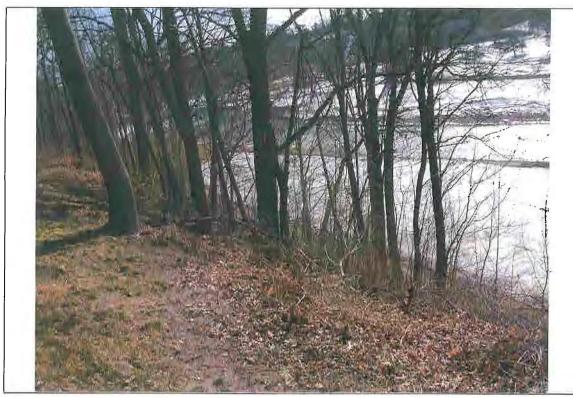
Photo No 3 - Upper Section of the Slope Cross Section

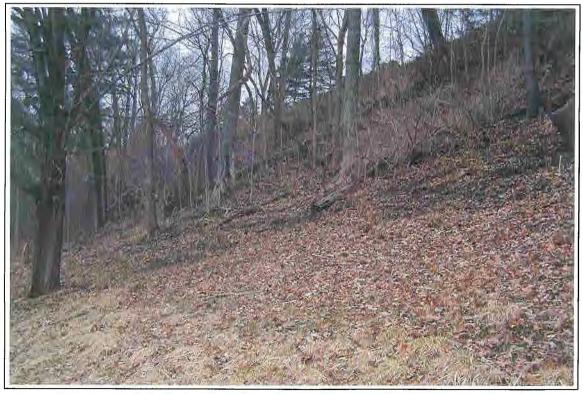
Photo No 4 - Mid and Upper Section of the Slope Cross Section

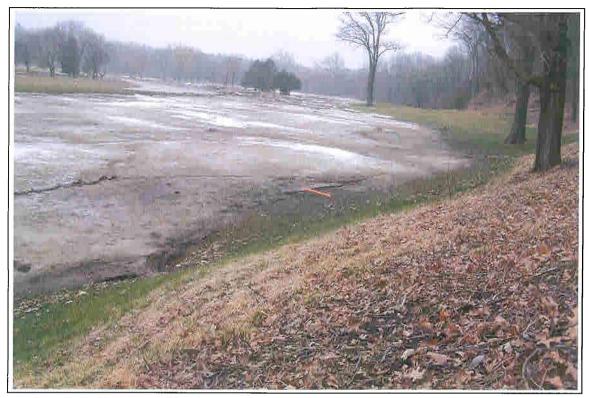
Photo No 5 - The bottom of the slope with the creek setback from the slope toe by a significant distance

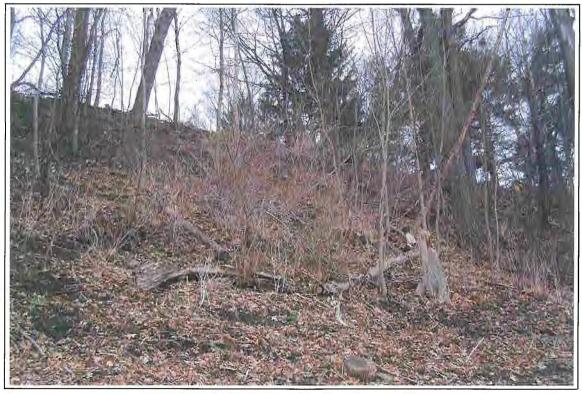
Photo No 6 - Mid Section of the Slope CrossSection

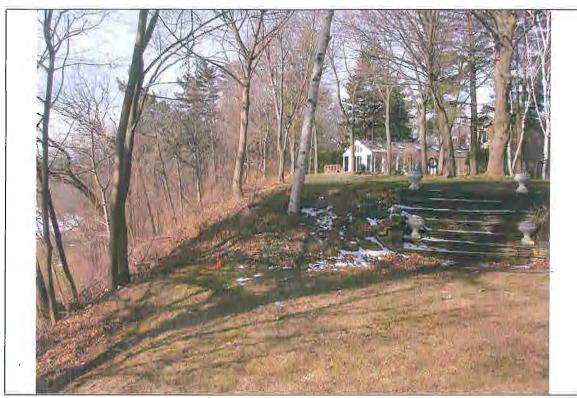
Photo No 7 - A view of the Upper Section & Flat Rear Yard from the crest of the slope

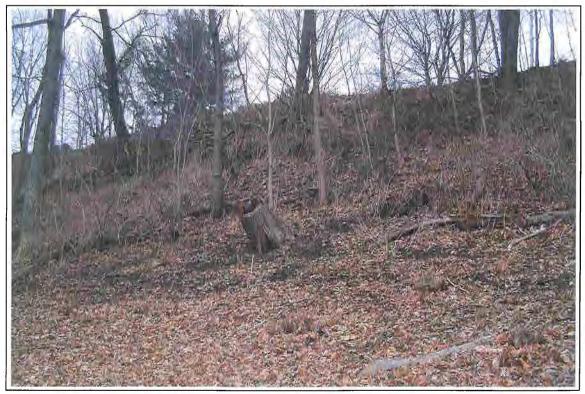
Photo No 8 – Lower Section of the Slope Cross Section
