**PHASE ONE
ENVIRONMENTAL SITE ASSESSMENT**

**6, 10, and 12 Queen Street South, 16 James Street, 0
and 2 William Street, Mississauga, ON**

City Park Homes (Streetsville) Inc.

October 18, 2023
Project: E-23-32-1

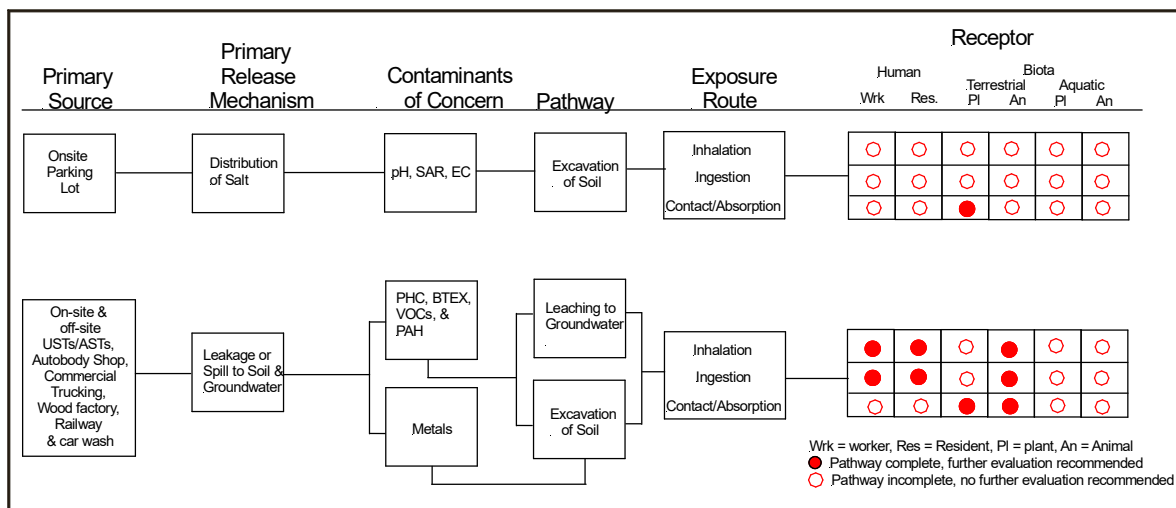
6.4 Phase One Conceptual Site Model

The conceptual site model qualitatively considers the potential interaction of primary sources of environmental concern, with suspected contaminants of concern, and the pathway(s) and exposure route(s) to the receptors. Target contaminants of SAR/EC/pH, PHCs, BTEX, VOCs and PAHs were identified with potential migration pathways to human and/or biota receptors.

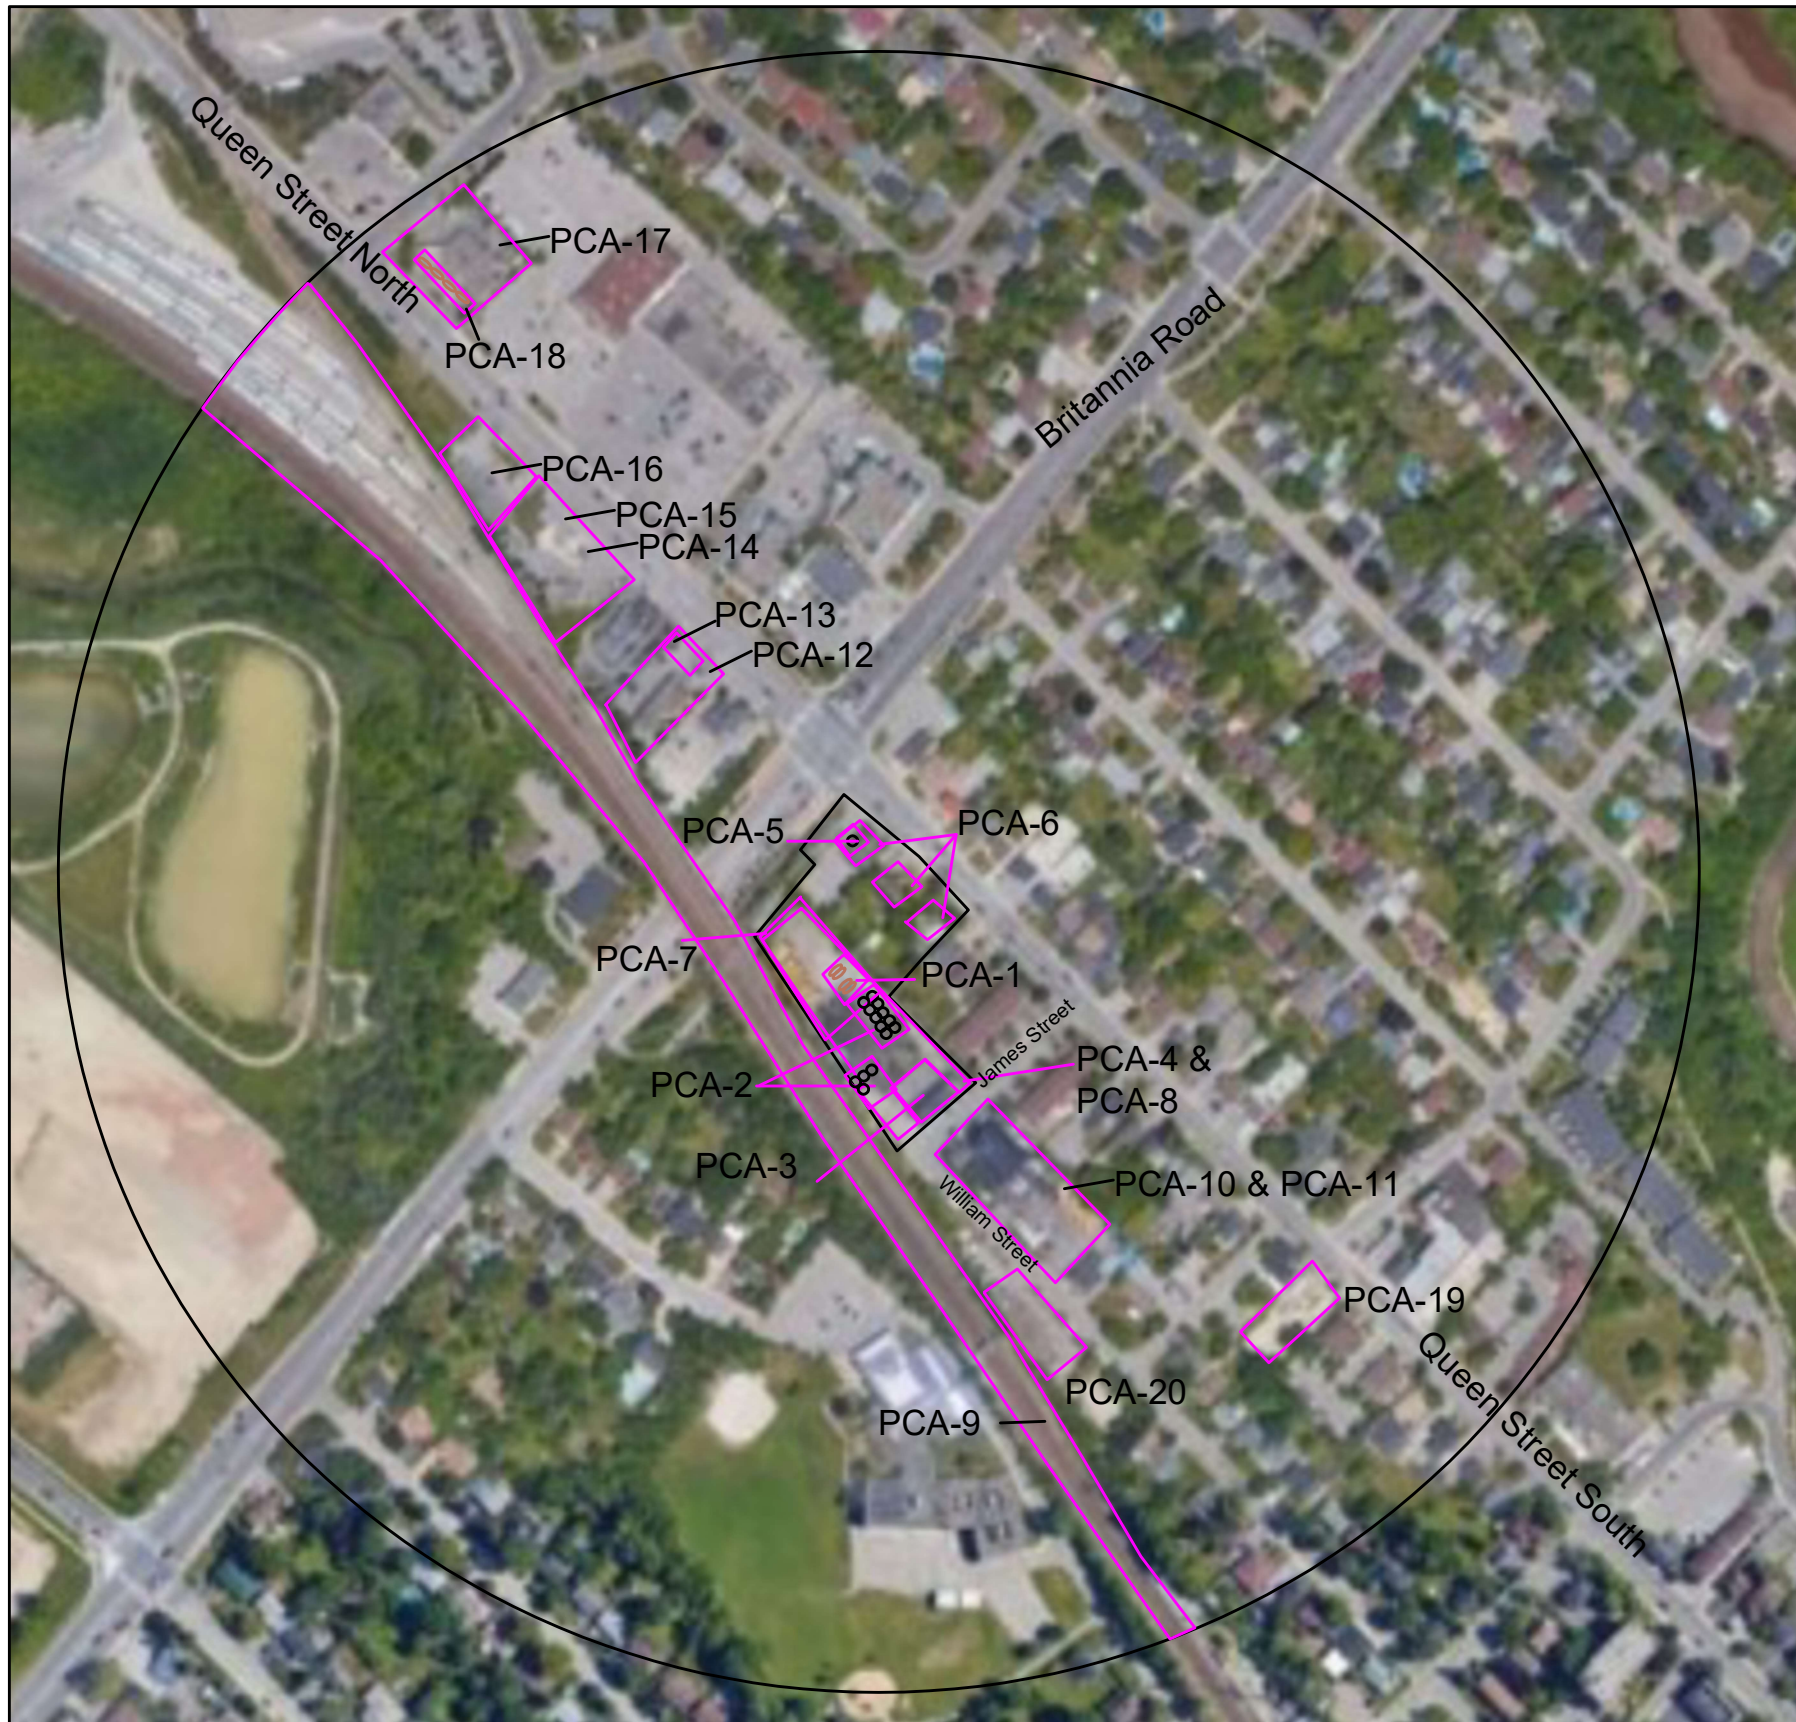
**Figure
4a**

- PCA-1: #28 Gasoline and Associated Products Storage in Fixed Tanks (USTs) - Historic
- PCA-2: #28 Gasoline and Associated Products Storage in Fixed Tanks (ASTs) - Historic

- PCA-3/APEC-3: #27 Garages and Maintenance and Repair of Railcars, Marine Vehicles and Aviation Vehicles - Historic
- PCA-4/APEC-4: #30 Importation of Fill Material of Unknown Quality - Historic

- **PCA-2/APEC-2: #28 Gasoline and Associated Products Storage in Fixed Tanks.** Fourteen (14) historic Aboveground Storage Tanks (ASTs) were identified in the FIPs, ERIS and aerial photographs. Ten (10) ASTs (nine (9) 4,000L and one (1) 2,500L) were located west of the building at 16 James Street. Four (4) dyked ASTs (three (3) 20,000L and one (1) 22,000L) were noted southwest of the building currently known as 0 William Street. These ASTs are

- **PCA-3/APEC-3: #27 Garages and Maintenance and Repair of Railcars, Marine Vehicles and Aviation Vehicles.** Various garages were noted via FIPs, and Vernons, utilizing the building at 16 James Street from 1970s-2017, some commercial names identified were: Speed Associates, Streetsville Automotive, Ontario Commercial Fuels, Dundas Cars Wholesale, Mississauga Engines, Phil Strudwick Race Cars, and Chayne Enterprises Inc. The presence of these garages represents a PCA resulting in an APEC to the study sites soil and groundwater with potential contaminants of concern being Metals, PAHs, PHCs, and VOCs.

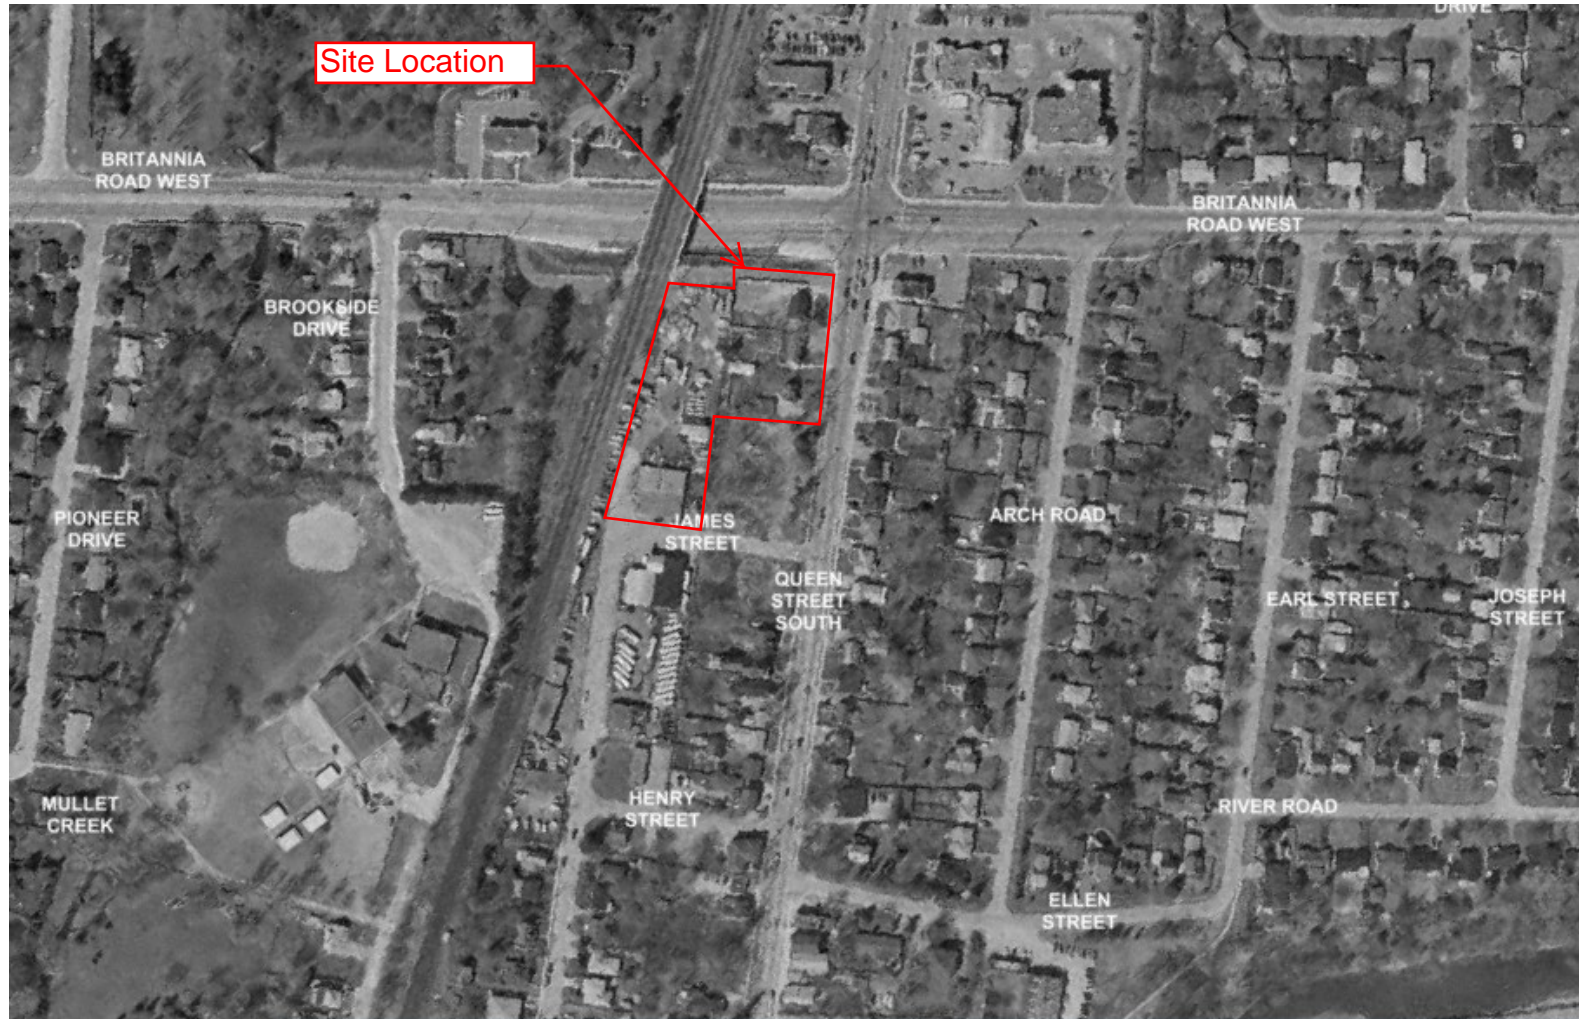
Historical Air Photo: 2000

2000	The 2000 aerial photograph showed Britannia widened to four (4) lanes, with 4 Queen Street South and the square building south of the road being demolished for the road widening. Numerous small sheds were noted behind 16 James Street.
2009	The 2009 aerial photograph showed an extension to the shed behind 12 Queen Street South. Numerous buses were identified behind 16 James Street, and along the William Street Stub Road. 2-14, & 16 James Street were noted to have newly built townhouses. The rear portion of 6 Queen Street South was developed into a large parking lot. Numerous small sheds and storage containers were identified at the back of 16 James Street.
2019	The 2019 aerial photograph showed six (6) residential dwellings and small vehicles parked on-site. There was a new structure with a shed roof dividing the rear yard, and several containers or bulk-lift units.
2022	All buildings along Queen Street and the building on William Street were demolished leaving one (1) building on 16 James Street. No other significant changes were noted.

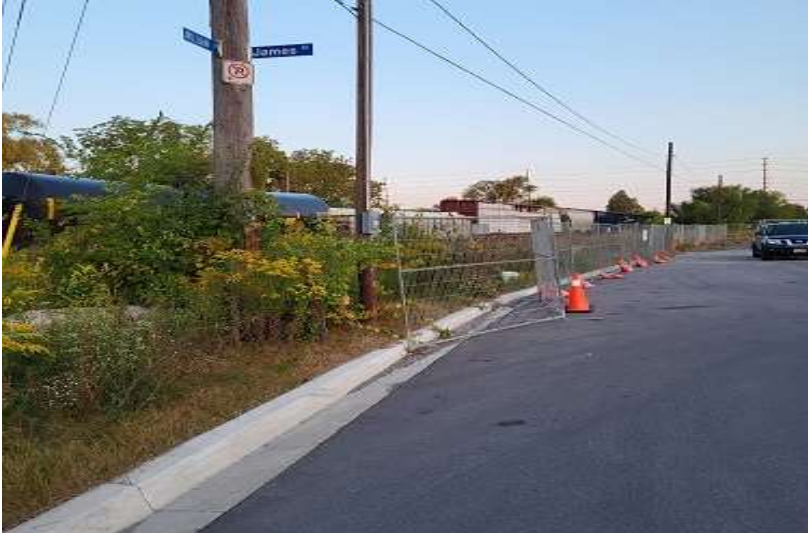
<p>Entrance to 0 William Street and the railway west adjacent, photo facing northwest.</p>
2	 	<p>Study site, facing northeast towards south corner of site from intersection of James Street and Wilson Street.</p>
3

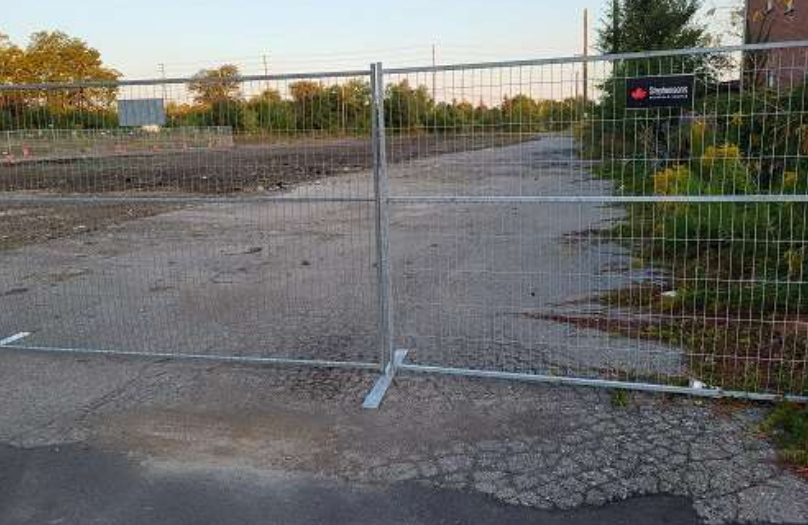
<p>Entrance way to 2 William Street and 16 James Street, photo facing north from southeast corner of site along James Street.</p>

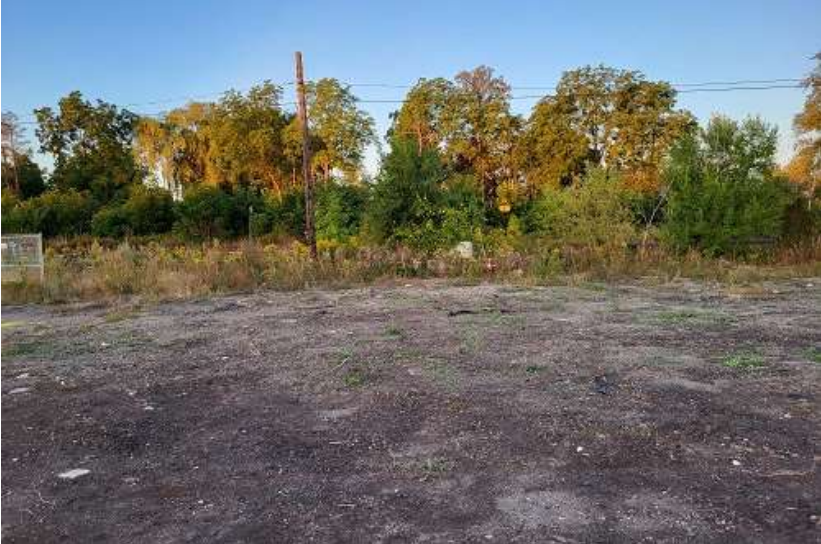
<p>Standing in the middle of the study site, facing southwest towards railway.</p>
8

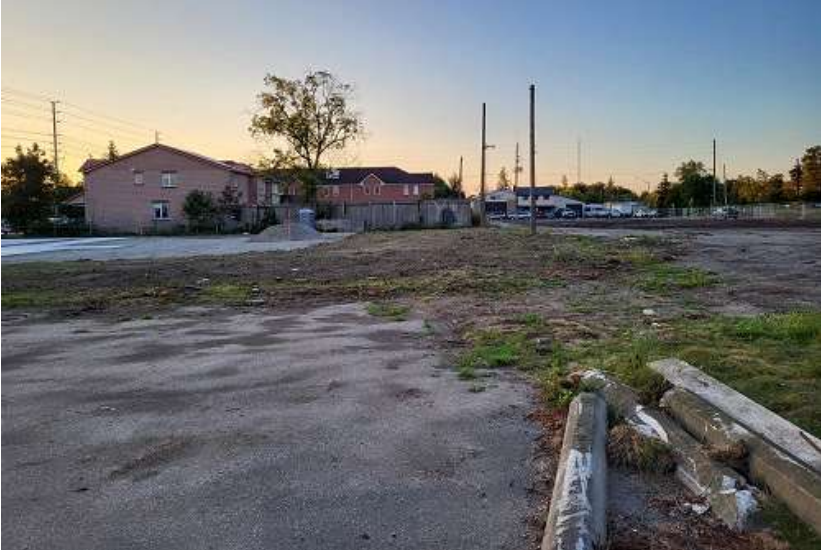
<p>Standing between 6 Queen Street and 2 William Street, illustrating the vacant study site, photo facing south.</p>
9

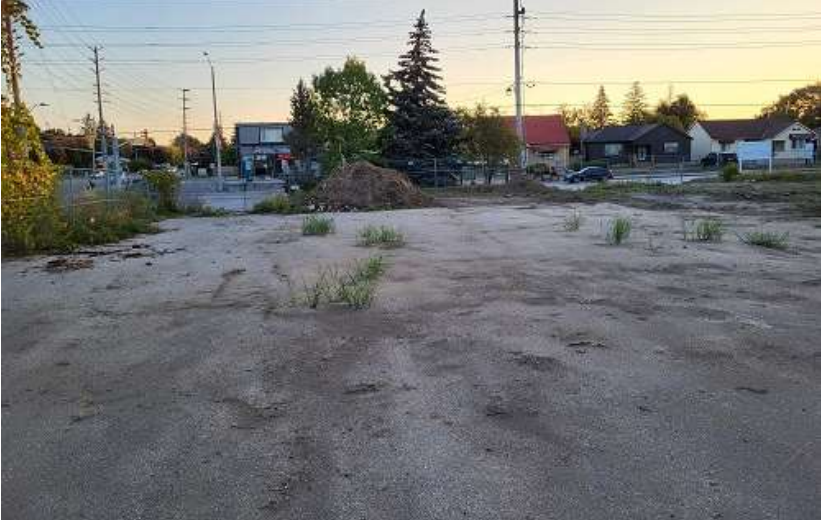
<p>View of soil pile at 6 Queen Street, photo facing northeast.</p> <p>The soil consisted of heterogeneous pile of top soil and grindings from trees on-site.</p>
