# Phase One Environmental Site Assessment

3033 Dundas Street West  
Mississauga, Ontario  
L5L 3R8

Safetech Environmental Limited

Safetech Project Number: 1-2240044

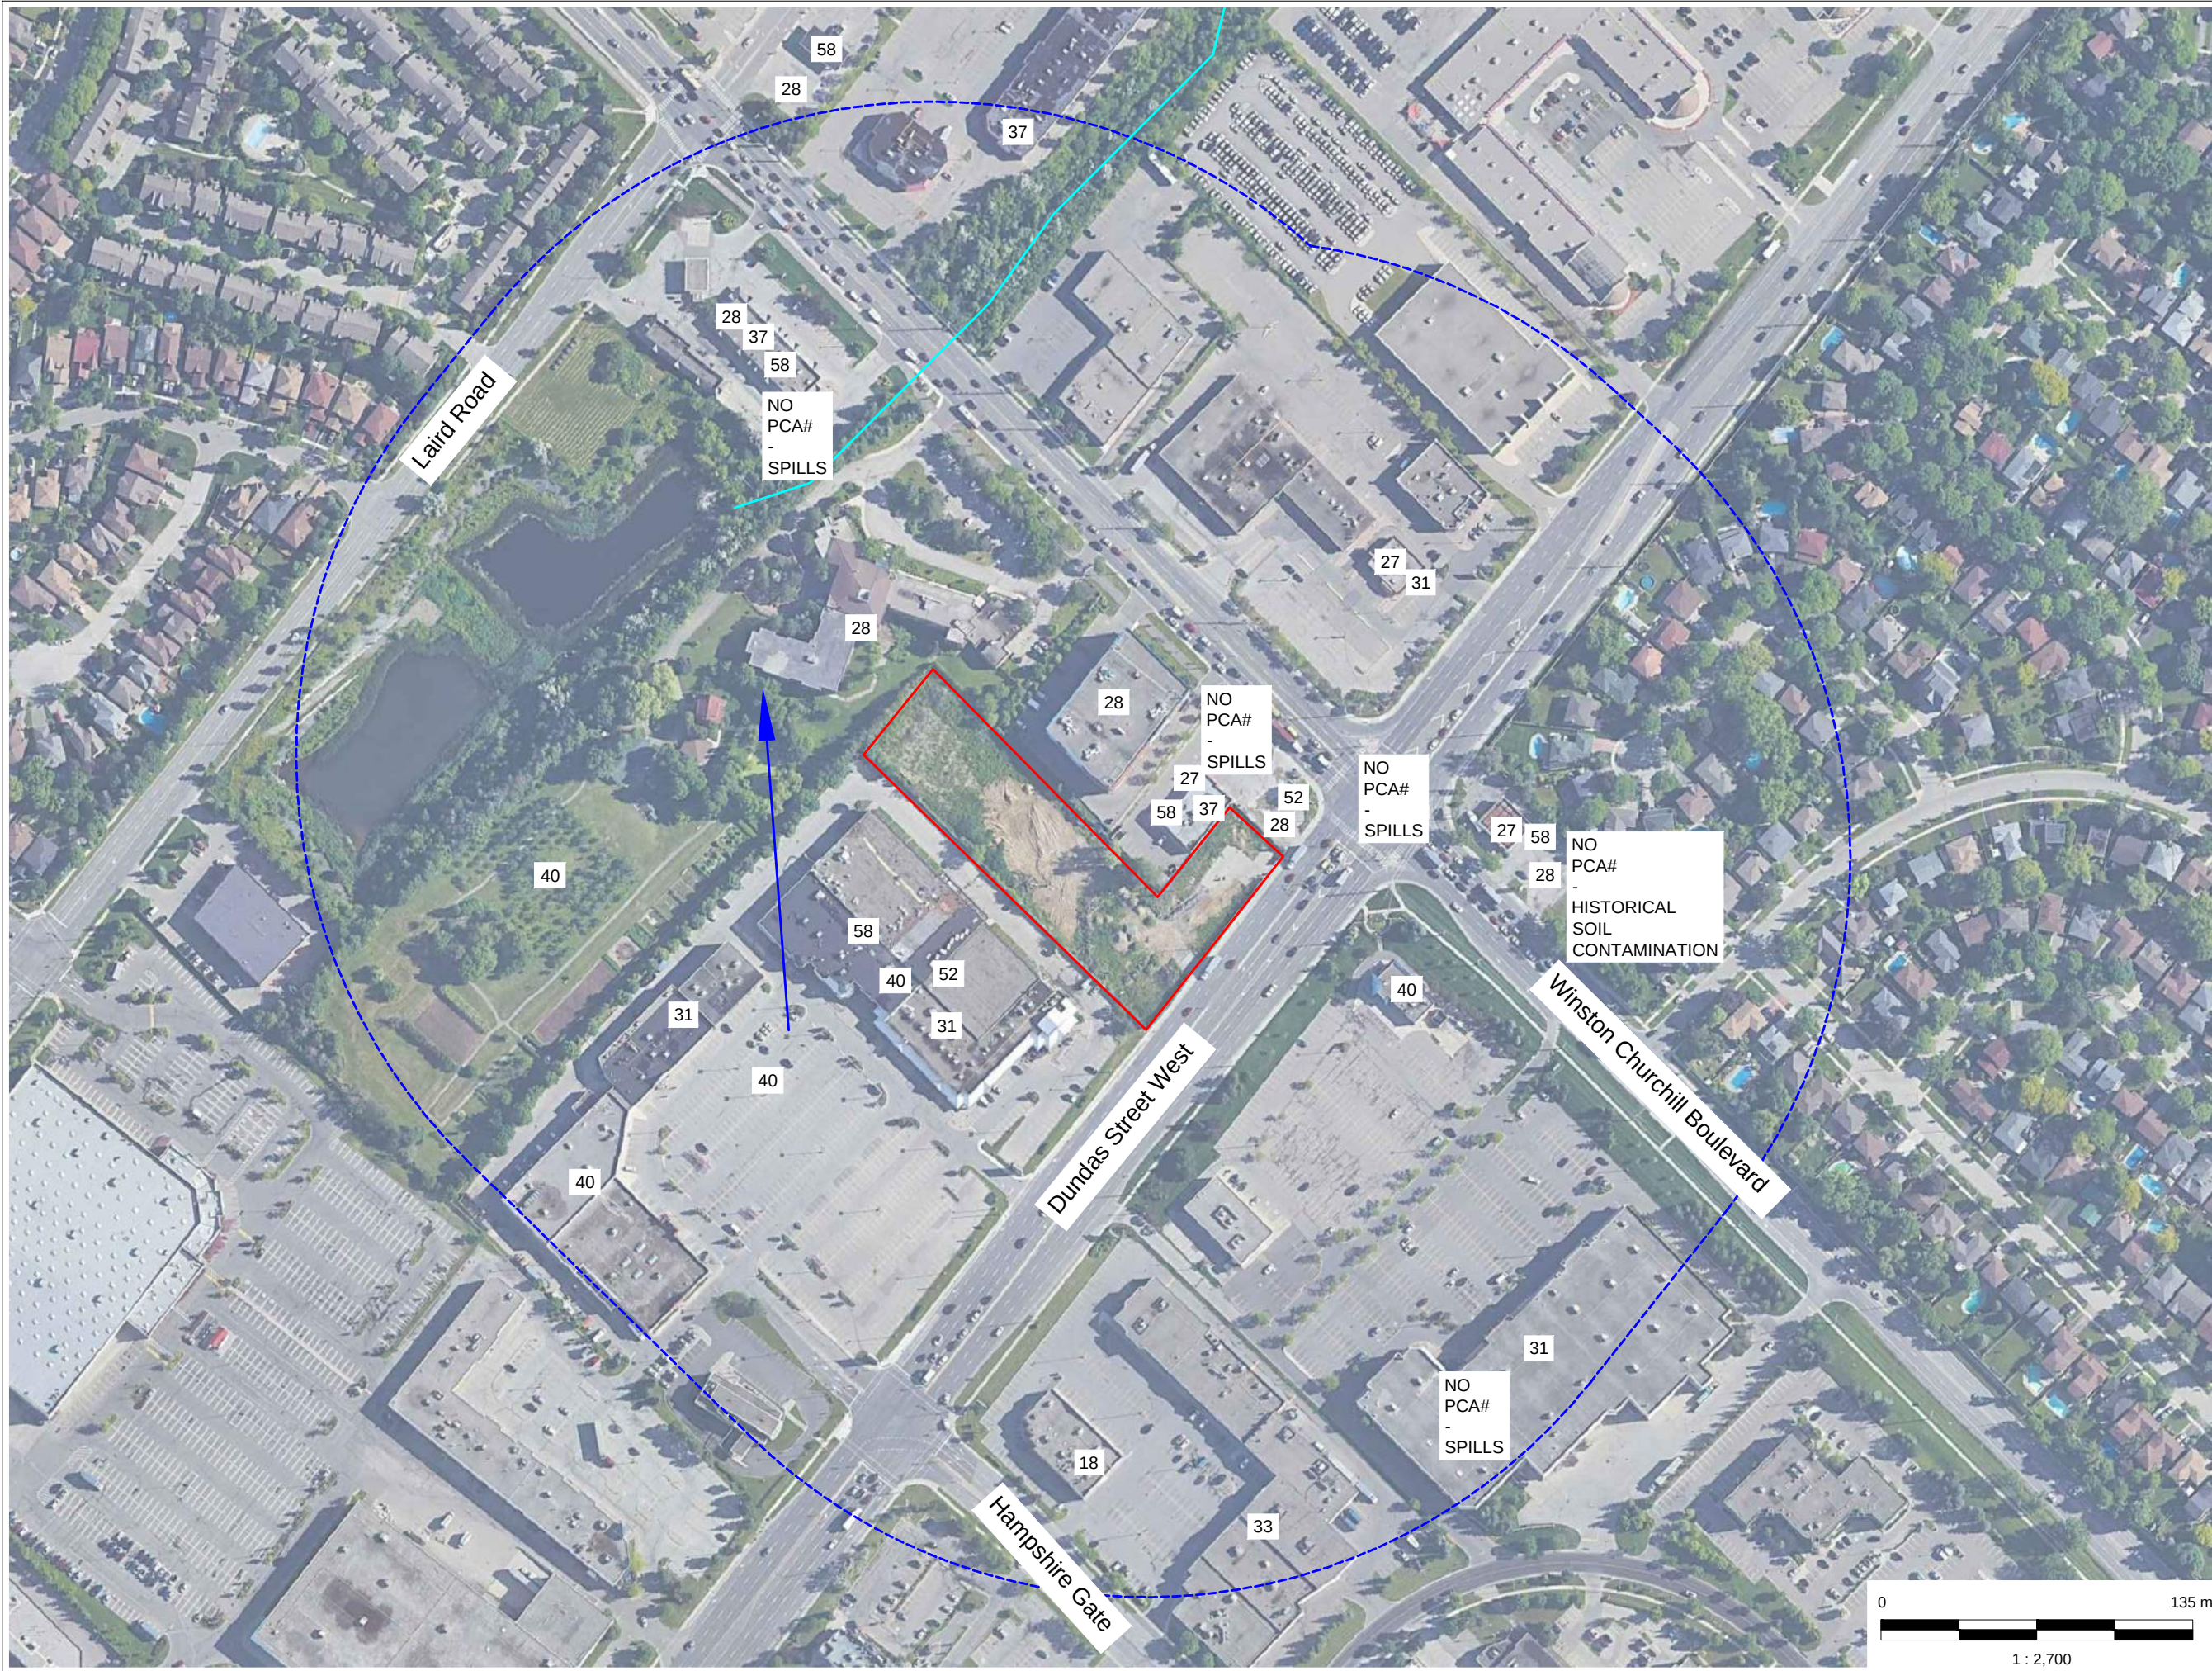
| <b>FIGURE:</b><br><b>3</b> | <b>DRAWN BY:</b><br>GB |

PCA - Potentially Contaminating Activities  
O.Reg.153/04 -- RECORDS OF SITE CONDITION - PART XV.1  
OF THE ACT under Environmental Protection Act, R.S.O. 1990,  
c. E.19

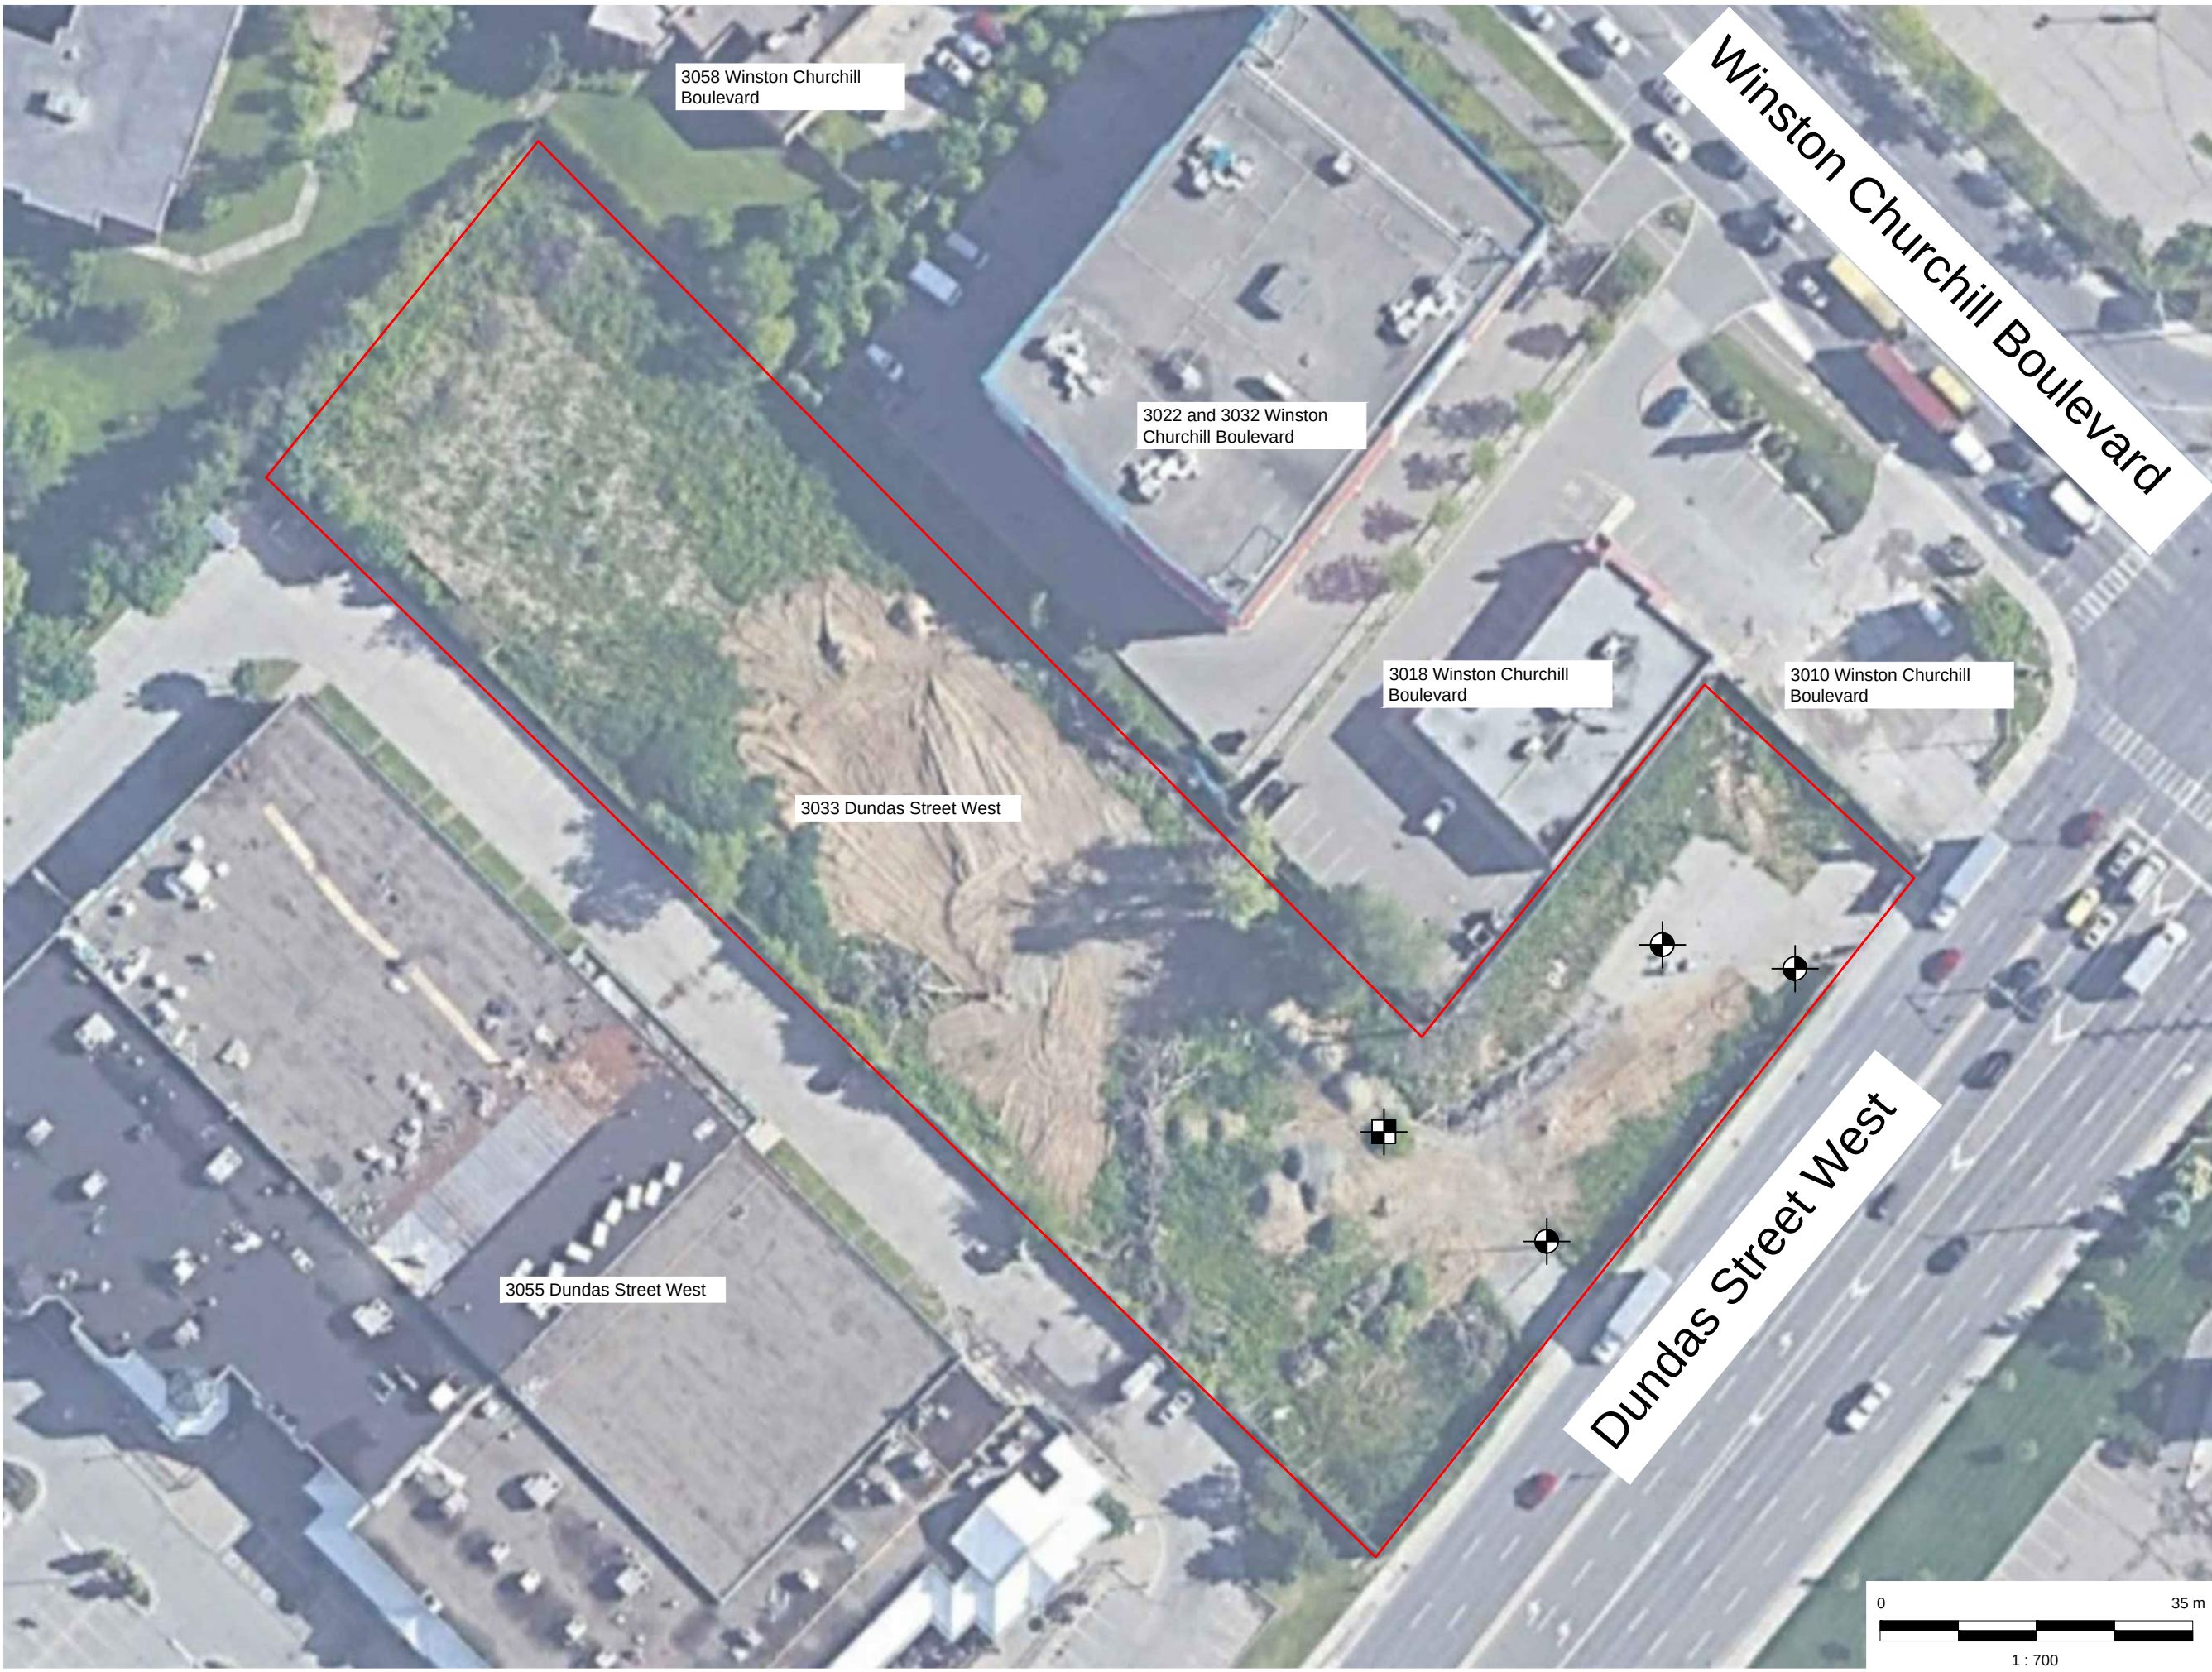
- LEGEND:**
- Approximate Phase One Property Boundary
  - Pre-existing Monitoring Well Location completed by Others
  - Abandoned Water Well

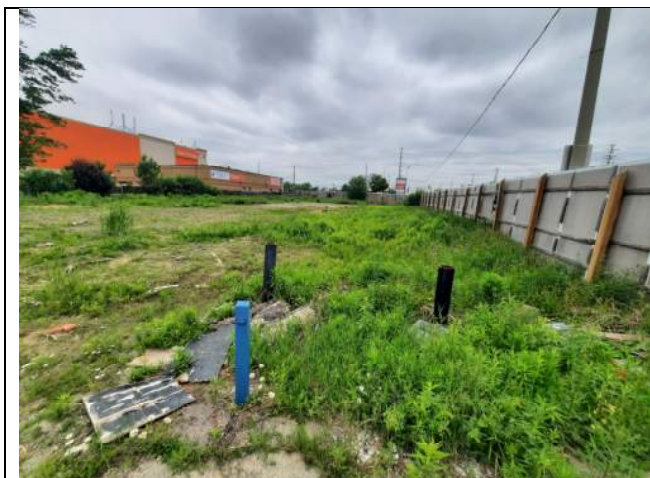
**Photograph 1:** View of the south portion of the Phase One Property, looking east with respect to reference north

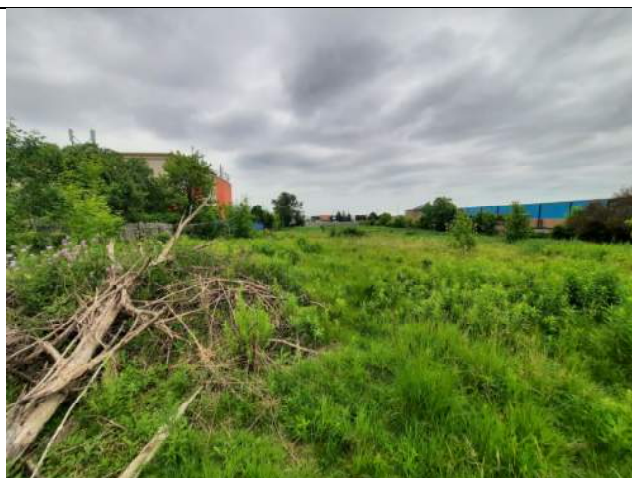
**Photograph 2:** View of the north portion of the Phase One Property, looking south with respect to reference north

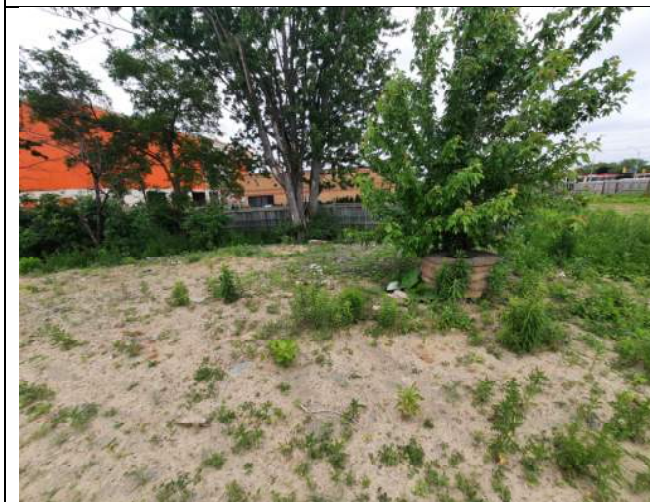
There were no potable drinking wells observed on the Phase One Property at the time of site reconnaissance. However, an abandoned water well was found in the central portion covered by a tree.

**Photograph 3:** View of a old water well covered by a tree on the central portion of the Phase One Property, looking east with respect to reference north

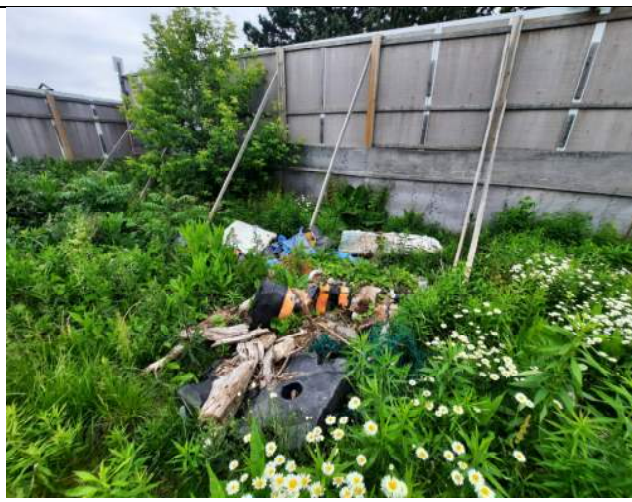
The Phase One Property was a L-shaped parcel of land that was vacant and was covered with overgrown shrubs and weeds. Construction debris and garbage were found haphazardly scattered across the property. The property was bordered by a wooden fence and is accessible from a gate fronting Dundas Street West. The surface cover was mainly un-graded soil. The Phase One Property was historically developed with several buildings used for residential purposes or as a hotel. These buildings were demolished in 2017.

**Photograph 4:** View of garbage and debris that was found scattered throughout the property

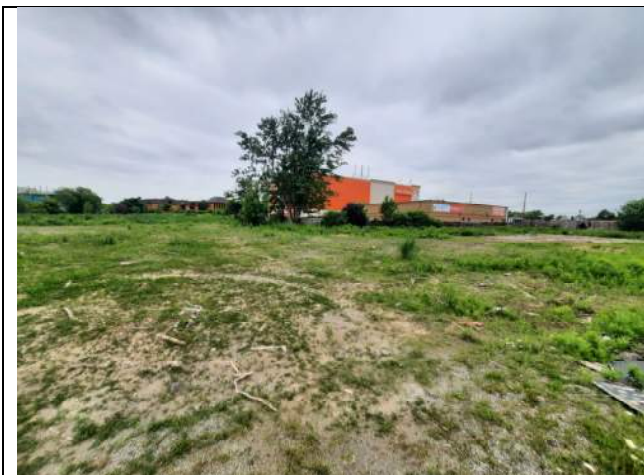
**Photograph 5:** View of the north and south portions of the Phase One Property from the southwest portion, looking northeast with respect to reference north

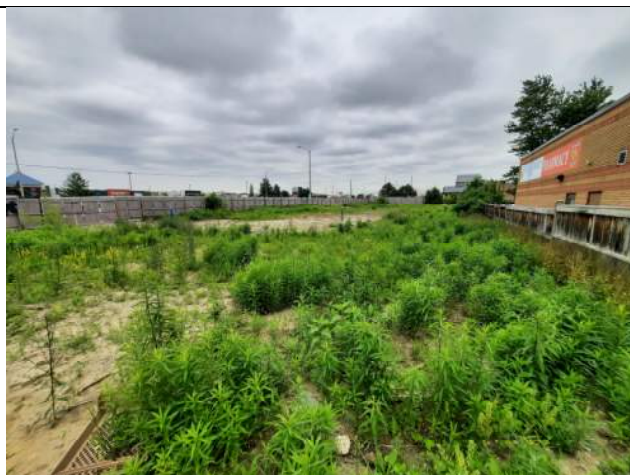
**Photograph 6:** View of two (2) of three (3) of the monitoring wells installed by others, looking west with respect to reference north

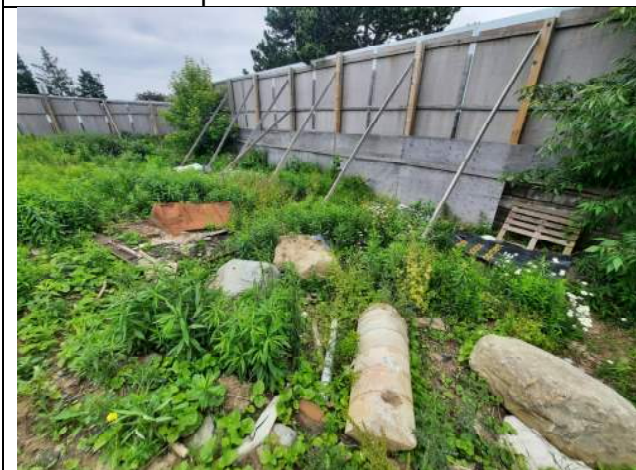
**Photograph 7:** View of more debris found on the Phase One Property

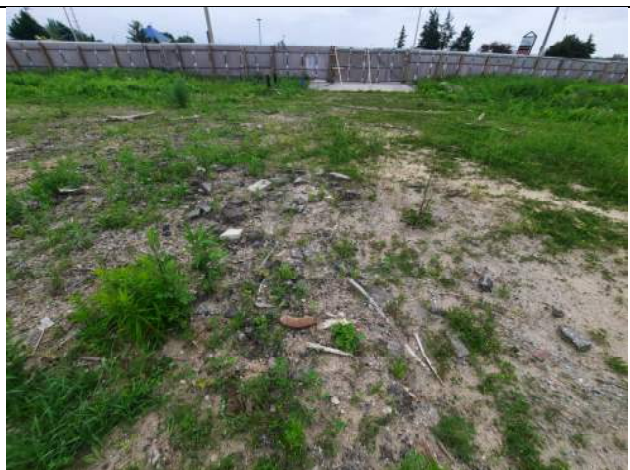
**Photograph 8:** View of the gate entrance to the Phase One Property, looking south with respect to reference north

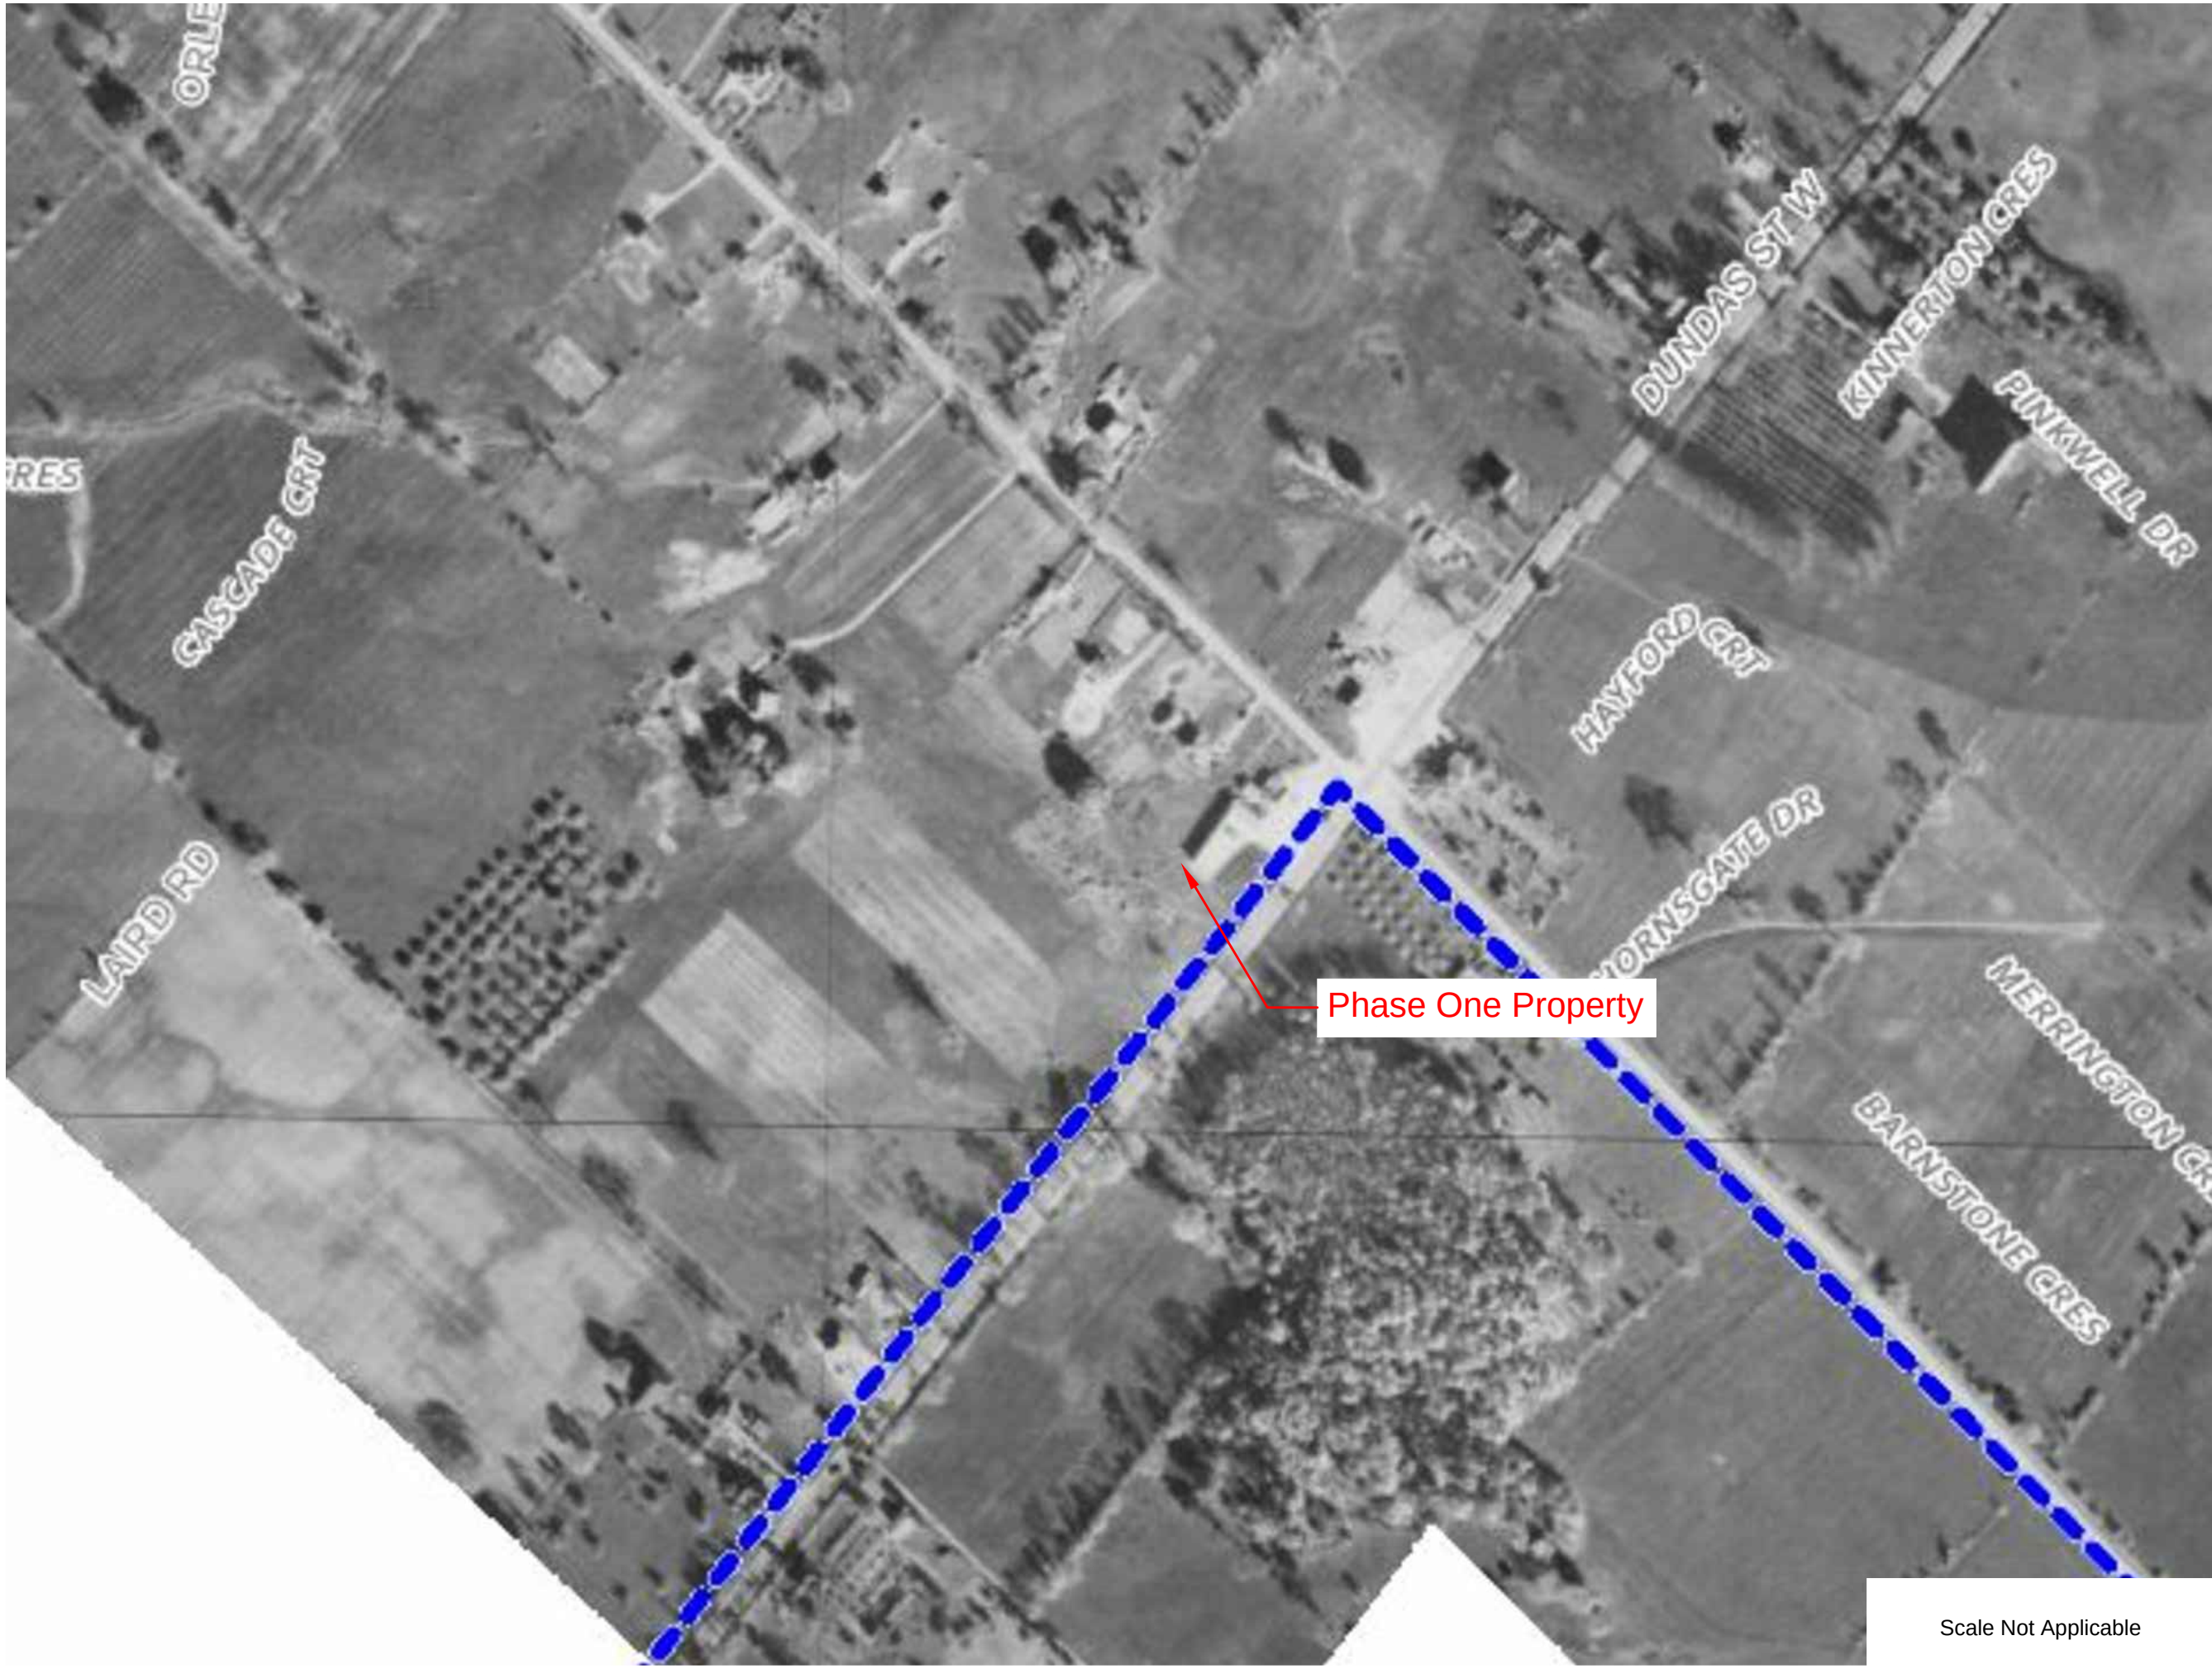
| YEAR:<br>1954 | DRAWN BY:<br>TH |

- 1954: The Phase One Property was developed with a rectangular building on the southeast portion of the property. Dwellings appeared to have been constructed on the east adjacent properties at 3010, 3018, 3022, 3032 and 3058 Winston Churchill Boulevard. A plantation or orchards was noted on the west adjacent property on 3055, 3105, 3115 and 3125 Dundas Street West.

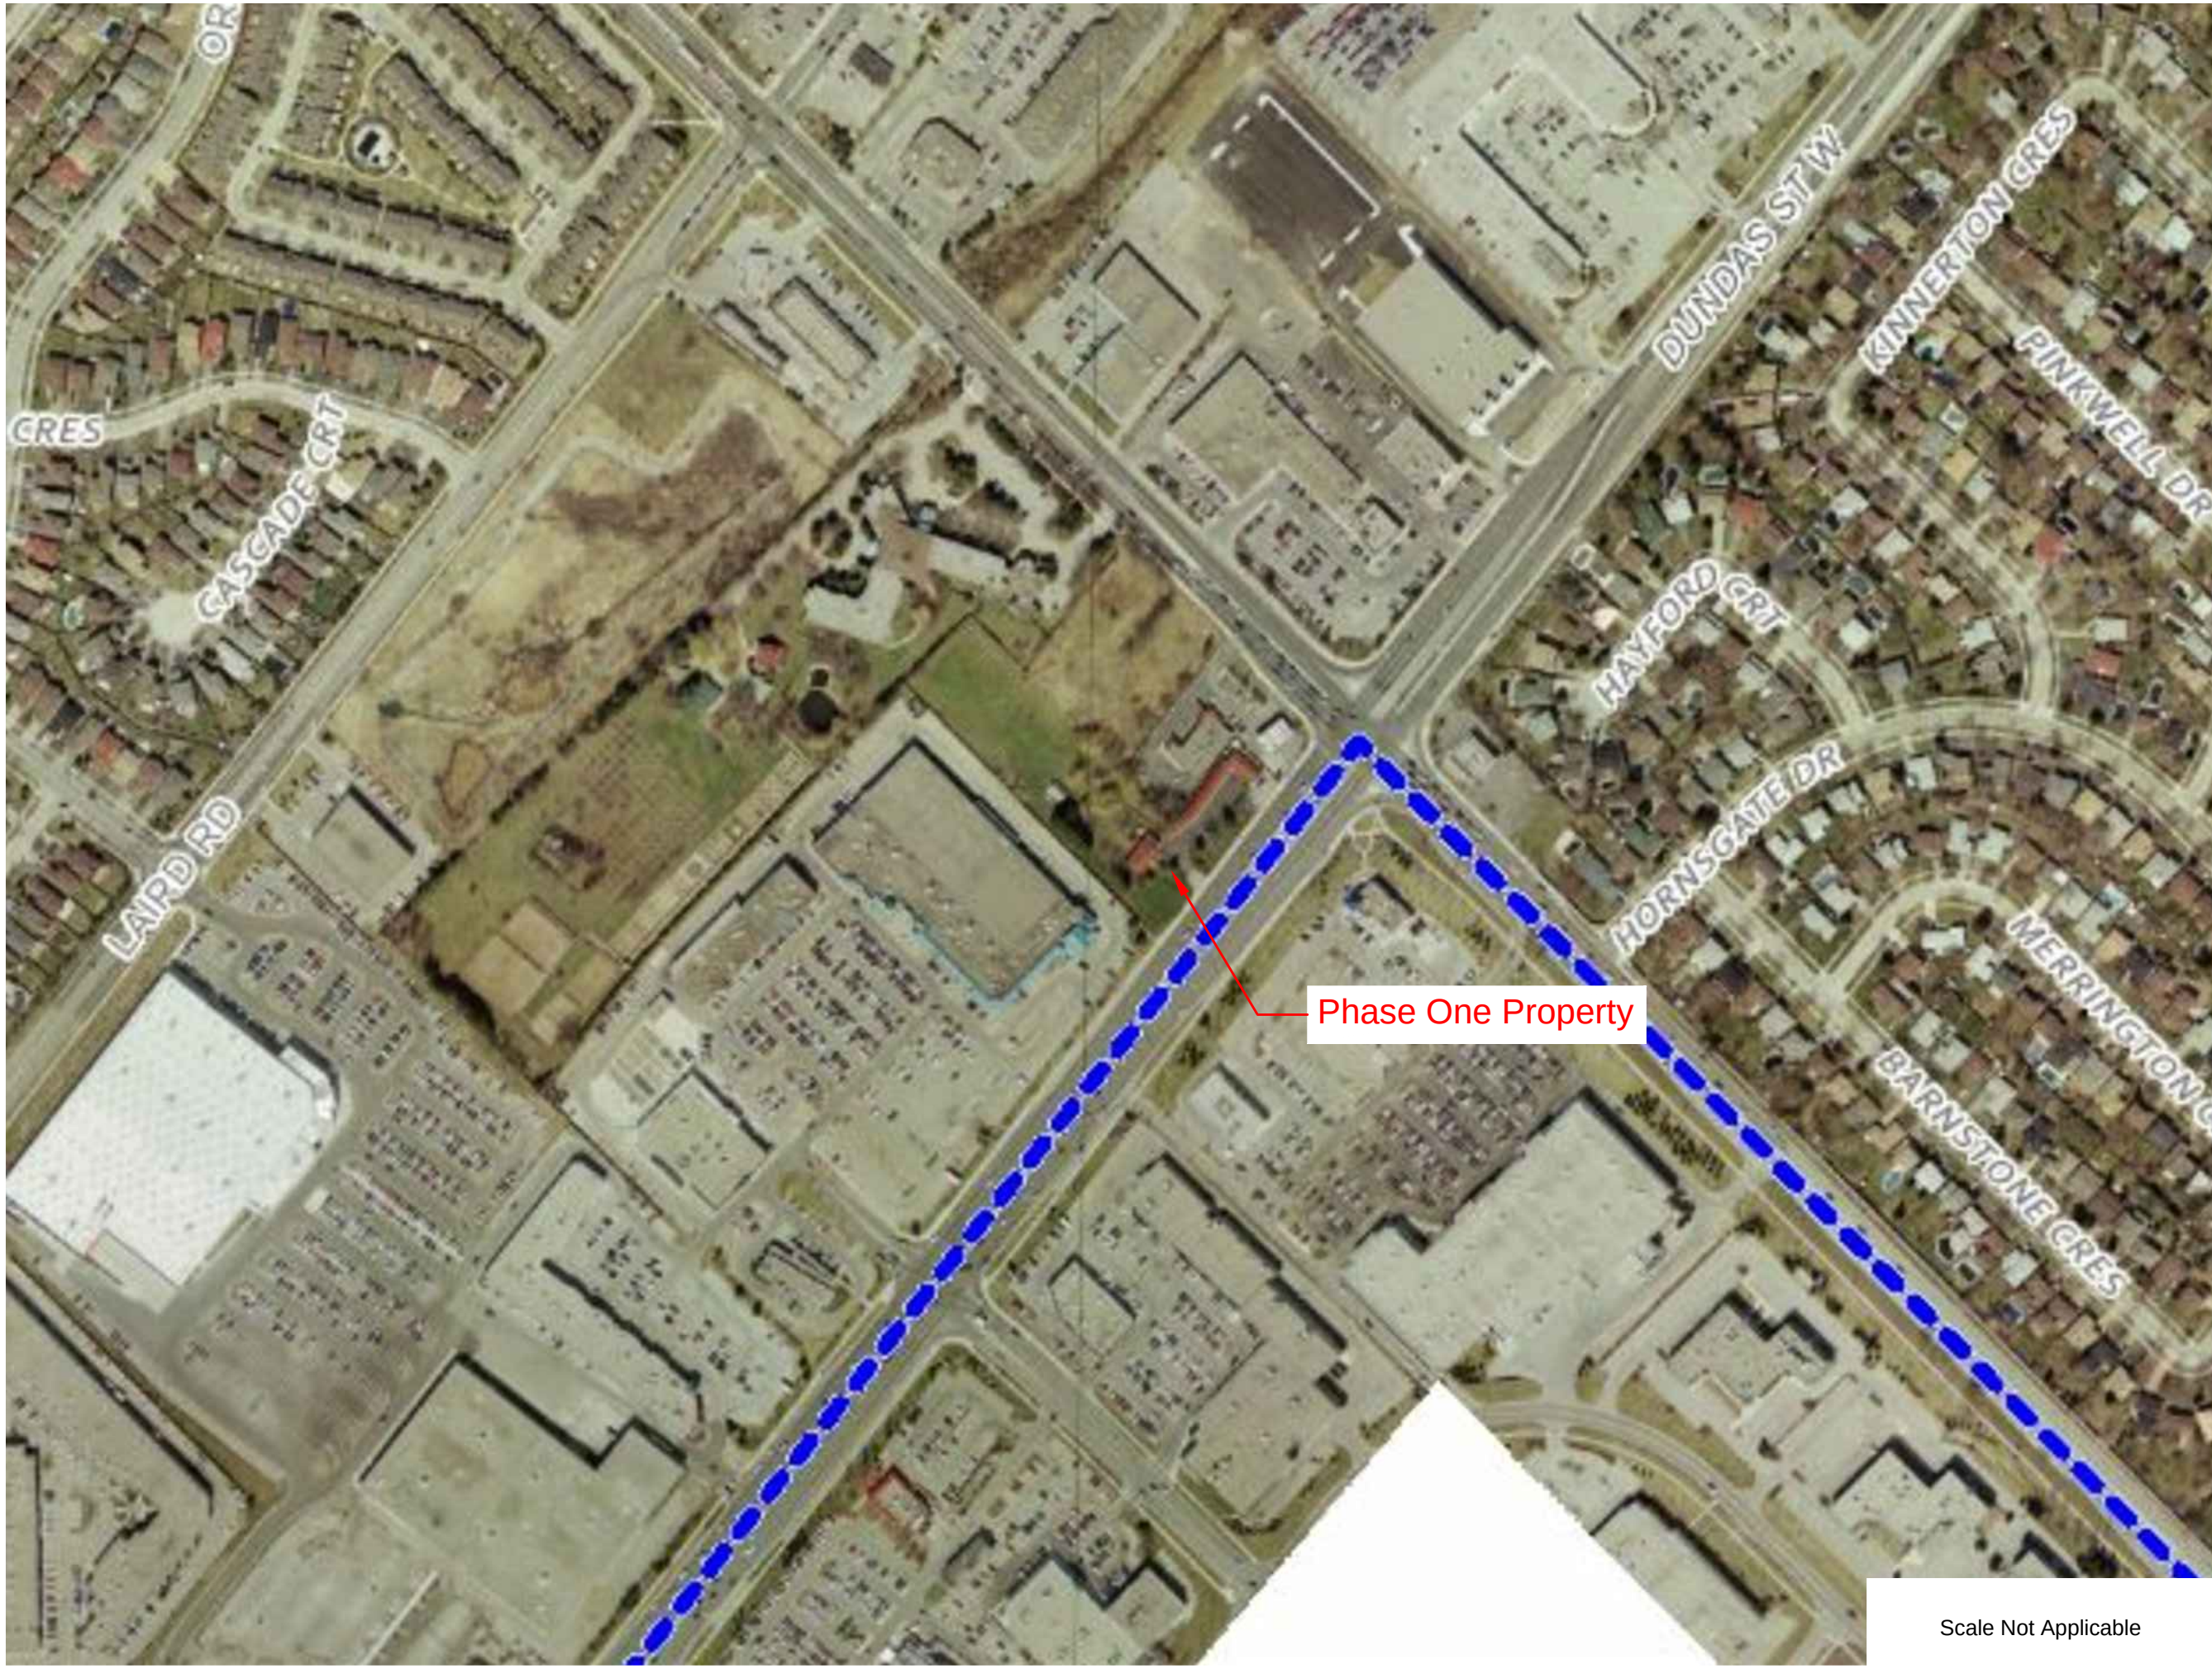
| YEAR:<br>2005 | DRAWN BY:<br>GB |

- 2005: The Phase One Property was constructed with several small structures at the central portion of the property behind the main buildings. The adjacent properties appeared to be similar to the previous aerial photograph, with the exception of what appeared to be commercial properties developed directly south of the Phase One Property, located between 2460 Winston Churchill Boulevard and 2525 Hampshire Gate. Generally, there appeared to be more commercial developments observed within the Phase One Study Area.
