Forest Park Circle - Phase 2
4100 Ponytrail Drive & 1850 Rathburn Road E
Mississauga, ON

Tree Preservation Plan

Date	Issued
July 2025	
Job Number	Drawn By
BTI-1801	DA
Scale	Checked By
1:500	JW, SB
Sheet Number	File Number
L005	FILE NO.

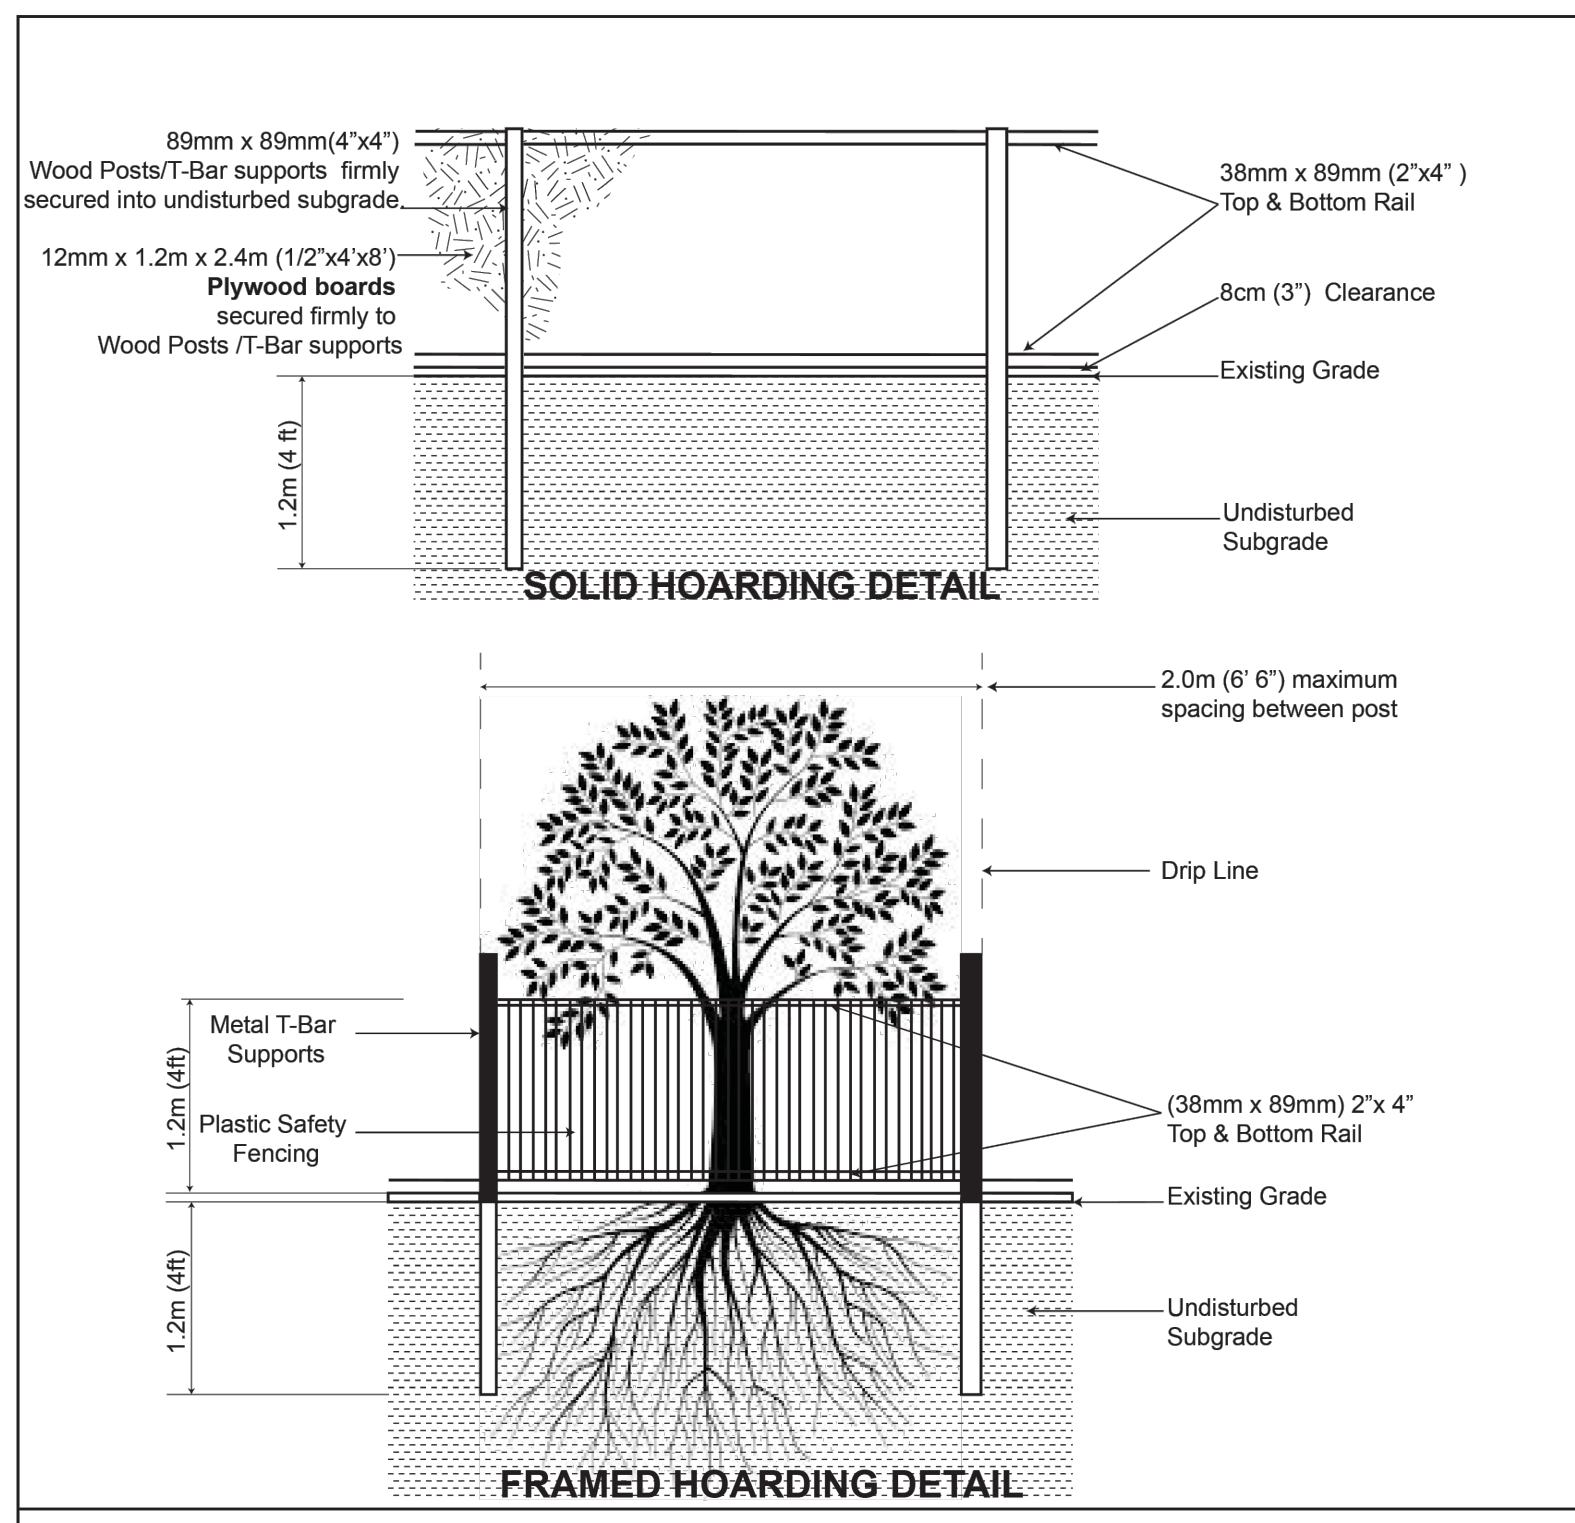
TREE PRESERVATION HOARDING

- NOTES:**
1. Hoarding details to be determined following initial site inspection.
 2. Private tree hoarding to be approved by Development & Design ; City tree hoarding to be approved by Community Services Dept.

3. Hoarding must be supplied, installed and maintained by the applicant throughout all phases of construction.
 4. **Inspection must be conducted by the Development and Design Division prior to removing any/all private hoarding.**

5. Do not allow water to collect and pond behind or within hoarding.
 6. **T-bar supports are acceptable alternative to 4x4 posts. U-shaped metal supports will not be accepted.**

7. **Plywood must be utilized for 'solid' hoarding. OSB/Chipboard will not be accepted for solid hoarding. Plywood sheets must be installed on "construction" side of frame.**

8. Applicant is responsible to ensure utility locates are completed within city boulevard prior to installing framed hoarding.
