Heritage Advisory Committee
JUN 19 2012

Heritage Impact Statement

**1570 Stavebank Road
Mississauga ON L5G 2V7**

Heritage Impact Assessment
St. Apostle Andrew Romanian Church
4030 Dixie Rd., Mississauga, Ont.

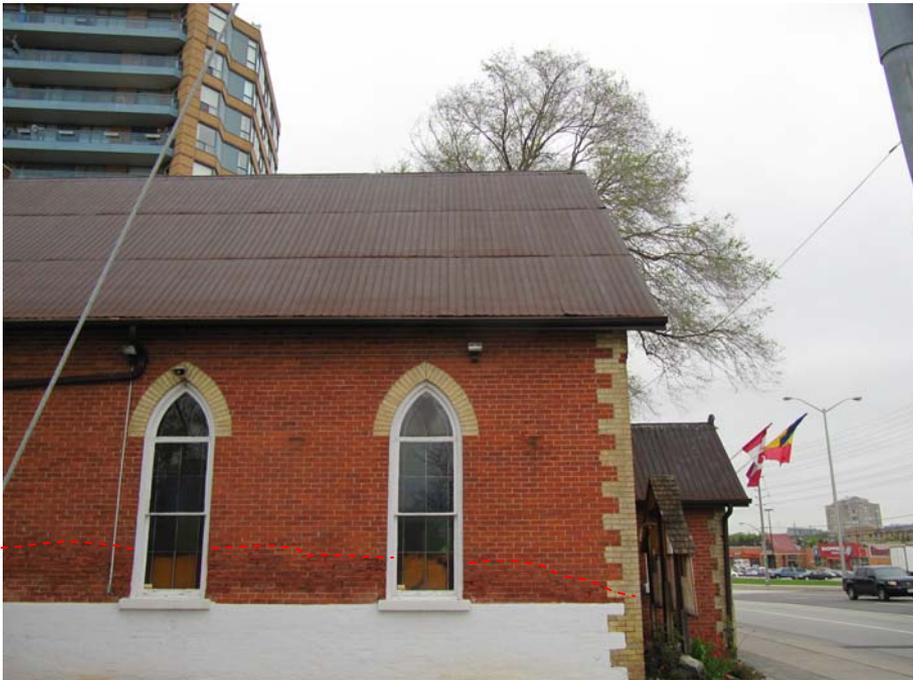
- Spalling brick on the south side in a band extending from the foundation up to approximately 5 ft. (1.5m) above grade. (Photo page 4.) The lower part of this area has been painted with what appears to be a breathable paint which showed no signs of failure but which may conceal earlier repairs. An area of spalling brick extends roughly 2 ft. above the top of this dado. Removing the paint may allow the wall to breathe in the lower part. The possibility is also that the brick in the lower part of the wall behind the paint has been replaced using a dense mortar and if the brick and mortar was poorly matched, that explains why the wall was painted and why the brick dado appears undamaged. That would also be a likely cause of the spalling brick above. If that is the case, removing the paint won't help. Our recommendation is to allow the paint to remain and replacement of only the most severely spalled brick, leaving quite a lot of brick with shallow surface spalling. The stone foundation has large open joints suggesting some mortar loss which should be repointed with a stronger mortar.

7. South side showing erosion of brick below dotted line.

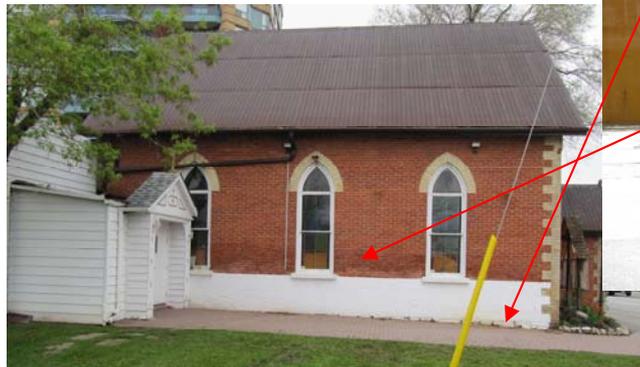
8. Spalling brick on south side

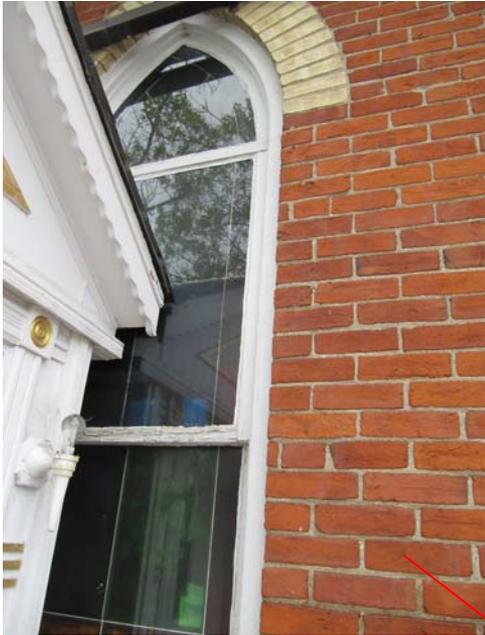
9. Window partly concealed by Parish Hall vestibule.

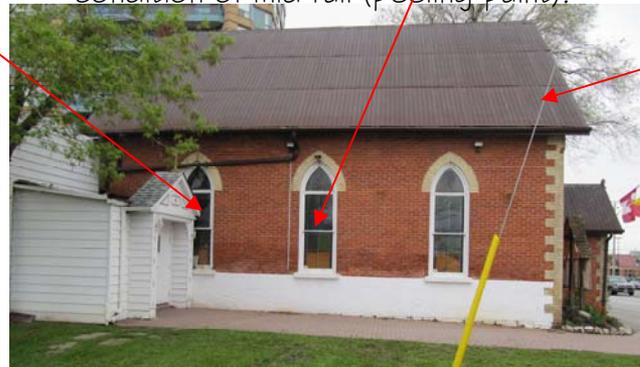
The roof is sheet metal, of a simple profile with surface fasteners, quite old and rusty with edges curling or loose. (Photos 7, 11, 14). Replacement is recommended with an appropriate profile prefinished metal roofing.

11. View showing sheets of rusty metal roof with edges curling.

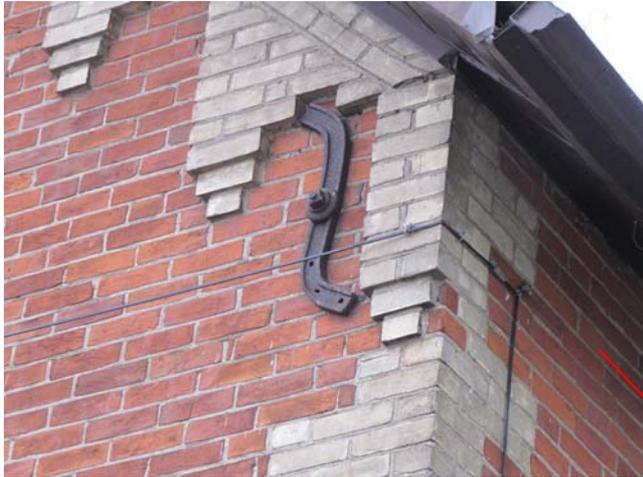
Although this building is almost 140 years old, the walls and brickwork are in very good condition. It appears that most of the original lime based mortar remains. Of note are two steel or iron tie rods. There are some areas of concern which include

12. Steel tie. Note brick detail.

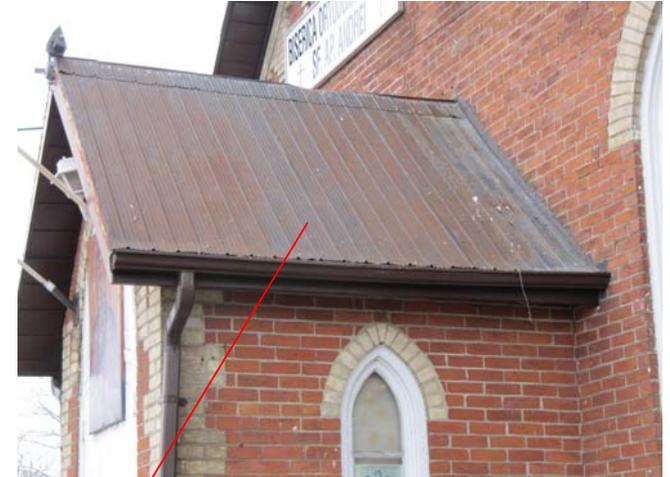
14. Vestibule roof.

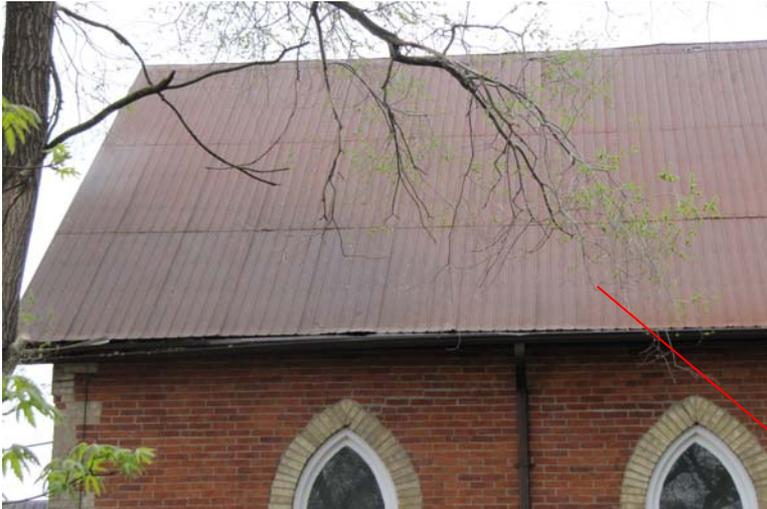
16. Roof on north side. Eavestrough falling off.

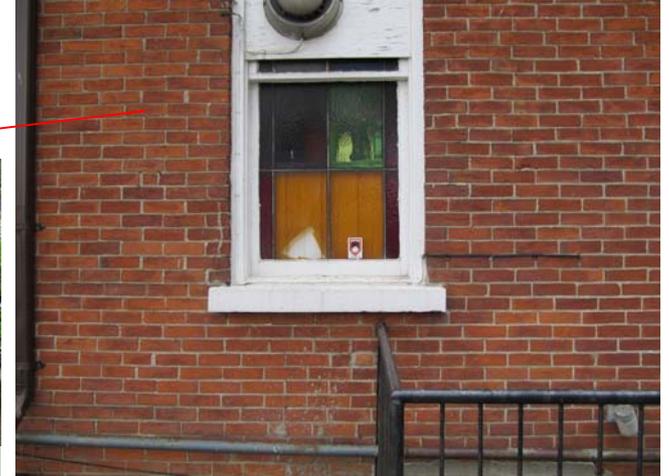
20. This window does not have a storm.

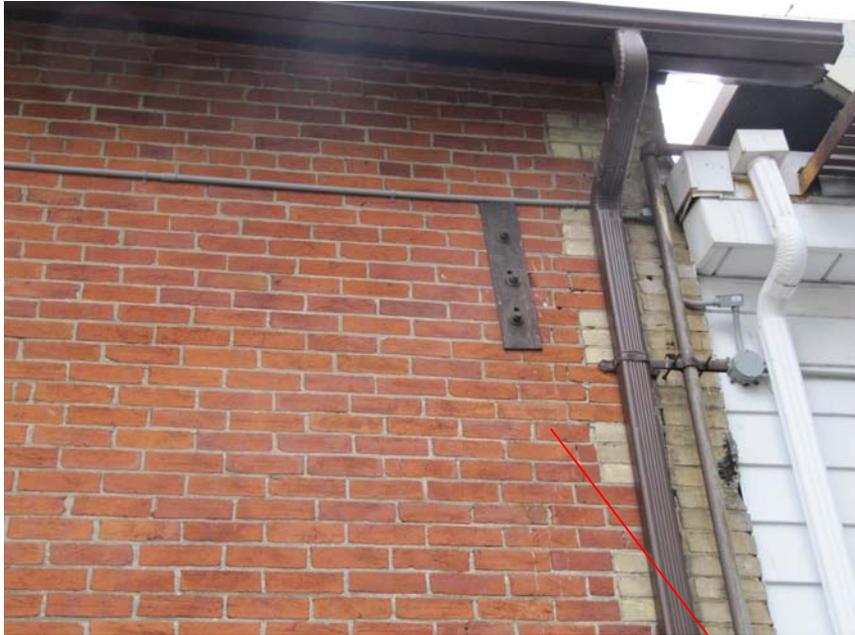
23. Steel tie rod and plate
