APPENDIX C
Fluvial Geomorphology Assessment

**PRELIMINARY FLUVIAL GEOMORPHOLOGY ASSESSMENT OF LITTLE
ETOBICOKE CREEK
DIXIE-DUNDAS FLOOD MITIGATION**

Prepared for:
CITY OF MISSISSAUGA

Prepared by:
MATRIX SOLUTIONS INC.

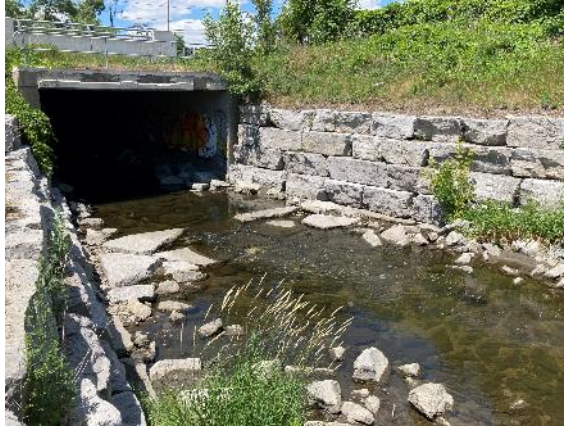
1 – Good (Amourstone)

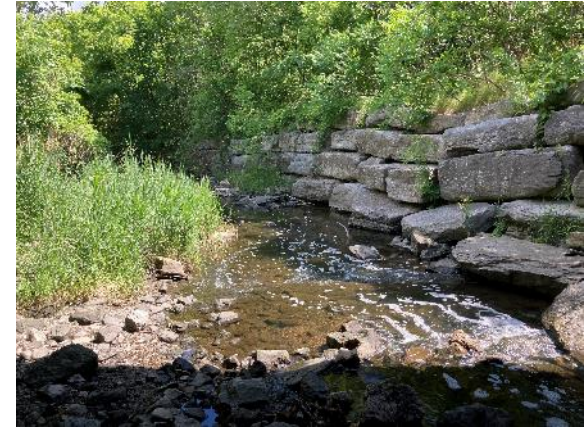
2 – Fair (Armourstone)

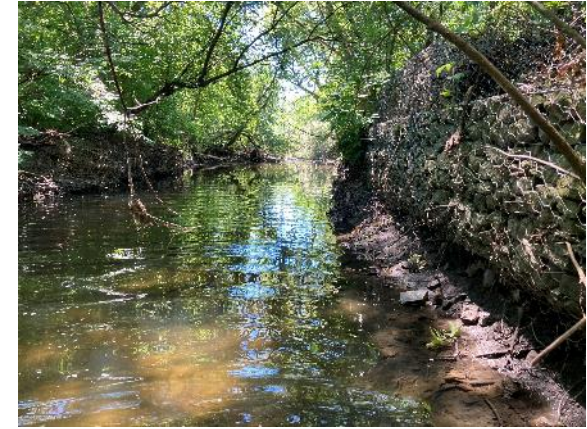
2 – Fair

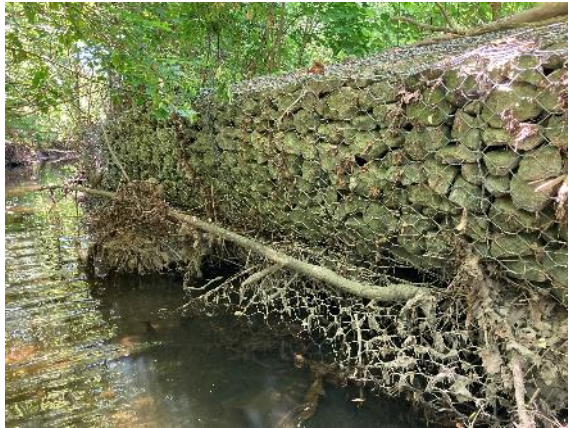
3 – Poor

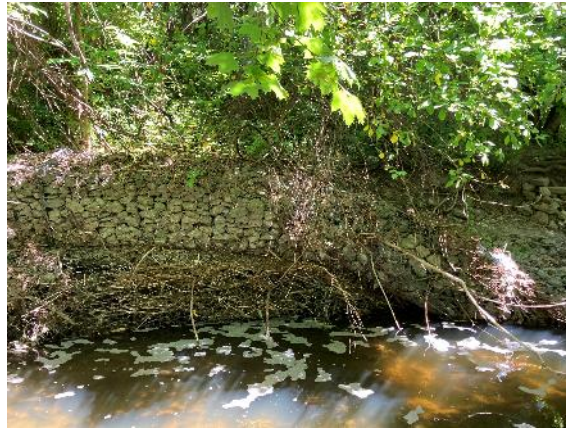
4 – Slump or Topple on Bank
