THURBER ENGINEERING LTD.

August 10, 2023

File No.: 25025

**EXPANDED GEOTECHNICAL DESKTOP STUDY
DIXIE-DUNDAS FLOOD MITIGATION
MISSISSAUGA, ONTARIO**

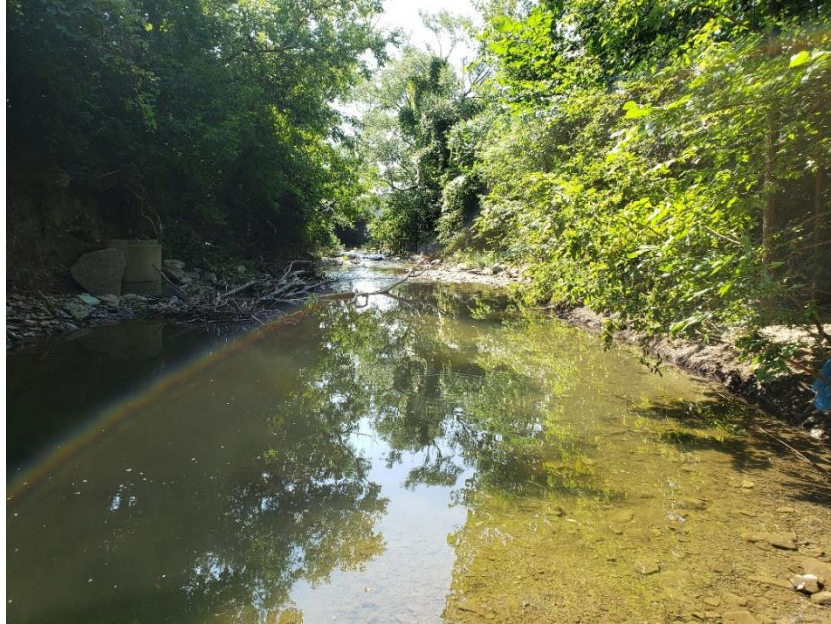
Photo 21: Looking downstream from behind Eddie's Meat Market. [taken June 2019]

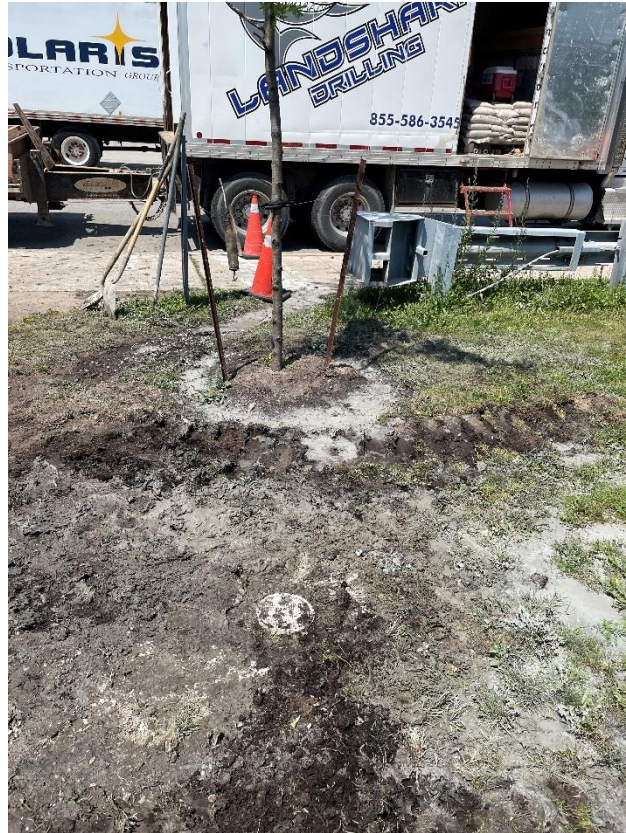
Photo 4. Looking north towards Borehole DUN-01 upon completion of drilling. [taken August 2021]

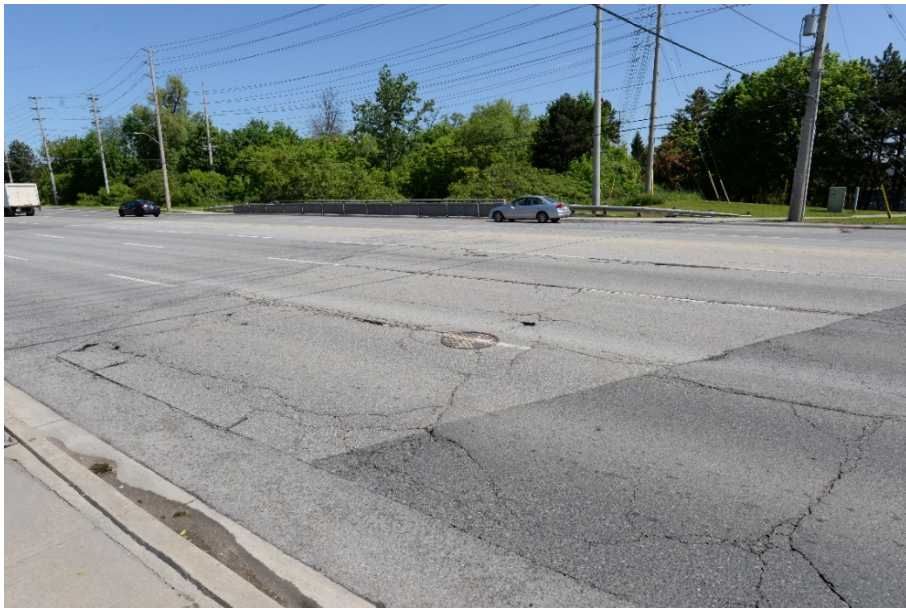
Photograph 2: Looking north towards Dixie Dundas Bridge from west sidewalk.

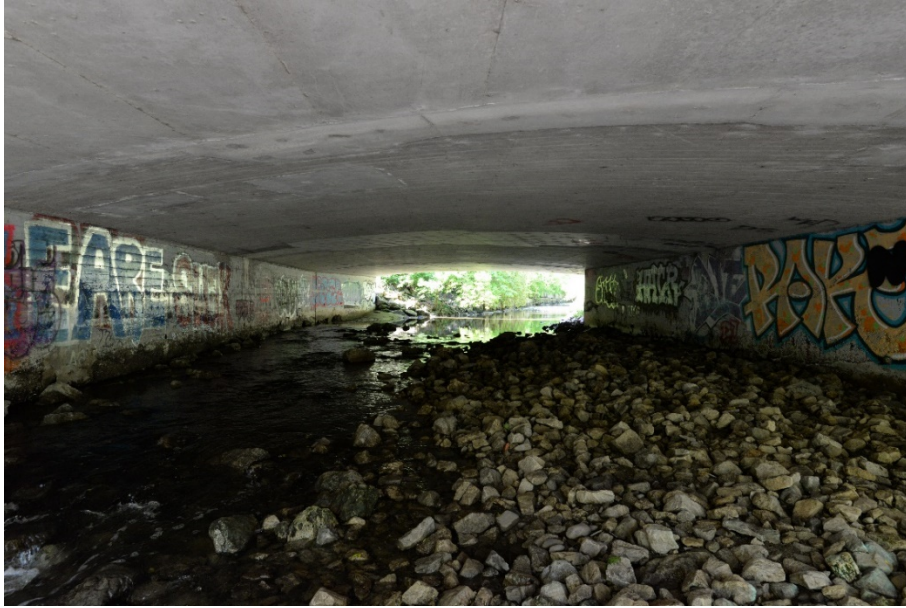
Photograph 5: Looking upstream from underneath Dixie Dundas Bridge.

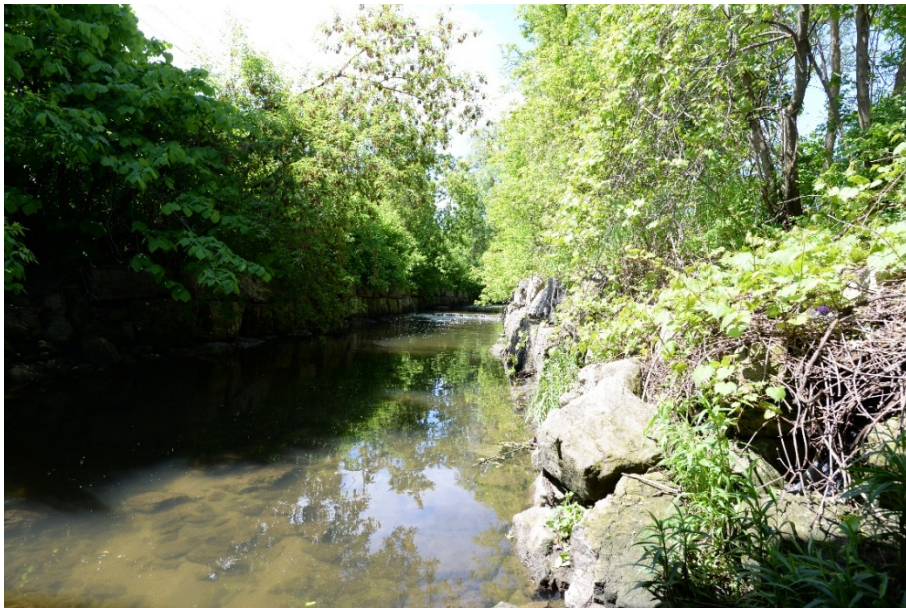
Photograph 8: Looking upstream from underneath Dixie Dundas Bridge.

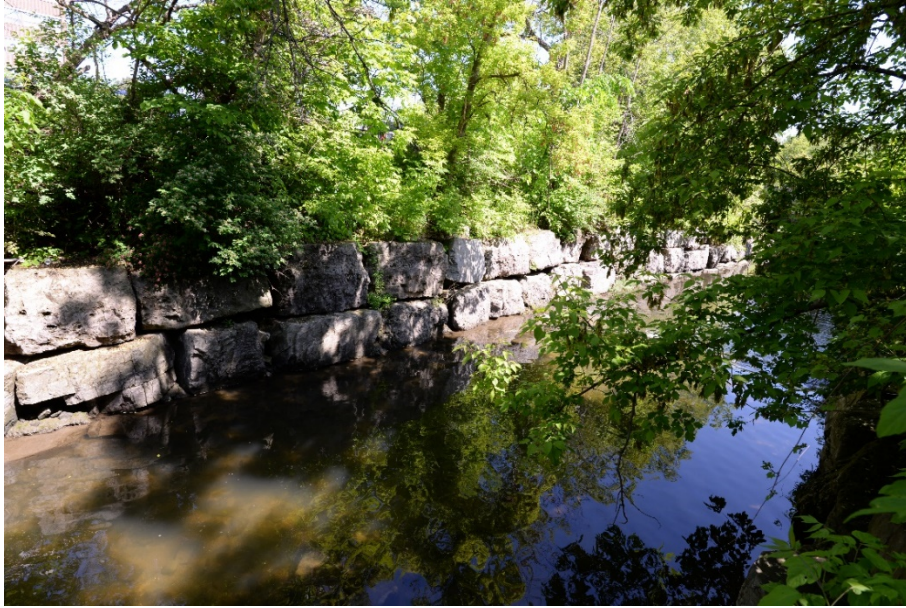
- Gabion baskets were noted along the east bank along Willowcreek Park.
- Thick vegetation was generally present along the slopes throughout the study area, except where the slope was eroded at the toes and face downstream of Dixie Road Bridge, as noted above.
- The creek flows in a southerly direction towards Lake Ontario.
- The creek bed generally consists of fluvial deposits comprising sand and gravel with cobbles and boulders as well as potential slabs of shale bedrock.
- Multiple downed trees were observed within the study area.

Photograph 9: Looking downstream from approximately 50 m west of Dixie Dundas Bridge.

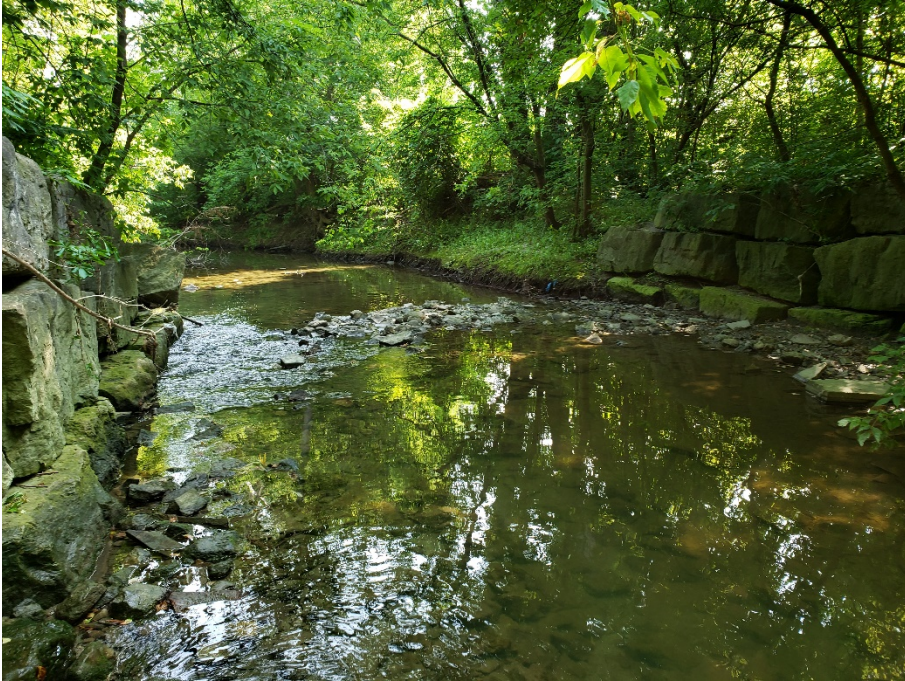
- The existing Dixie Road Bridge is a single span structure with abutments on the north and south sides of the creek.
- Concrete stormwater outfall structures with armourstone drop-spillways were observed, one on the north side of the creek approximately 7 m downstream of Dixie Road Bridge and one approximately parallel with Goldmar Drive.

Photograph 15: Looking downstream from a walking trail approximately parallel with Goldmar Drive.

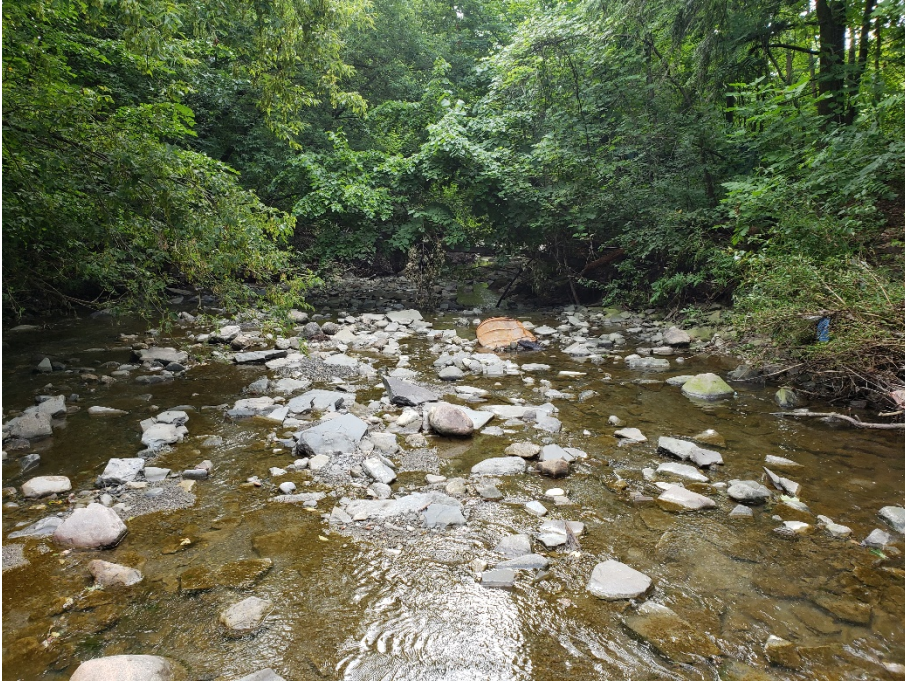
Photograph 17: Looking downstream from Willowcreek Park.

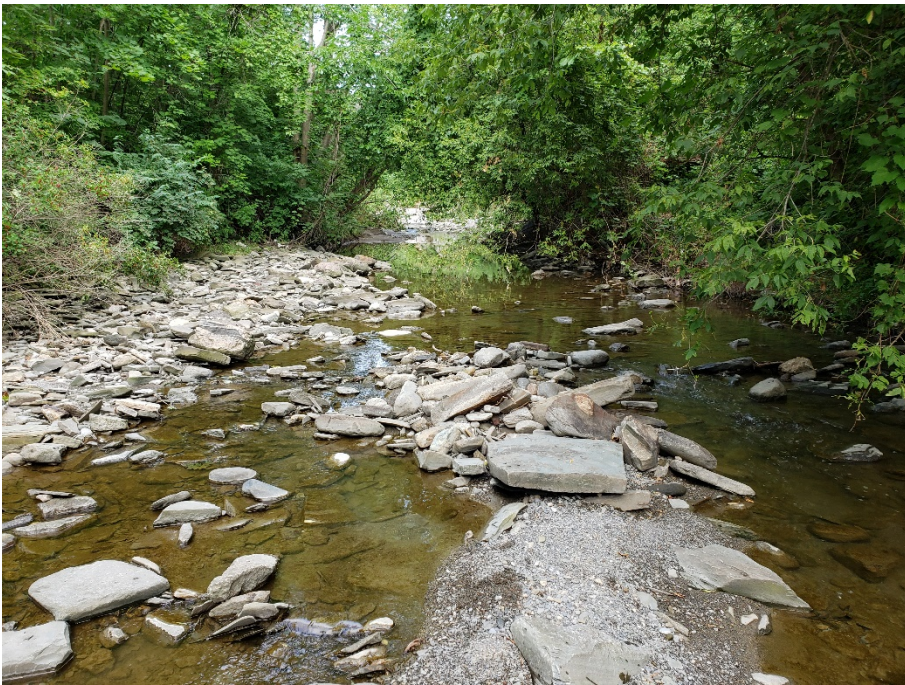
Photograph 18: Looking upstream from Willowcreek Park.

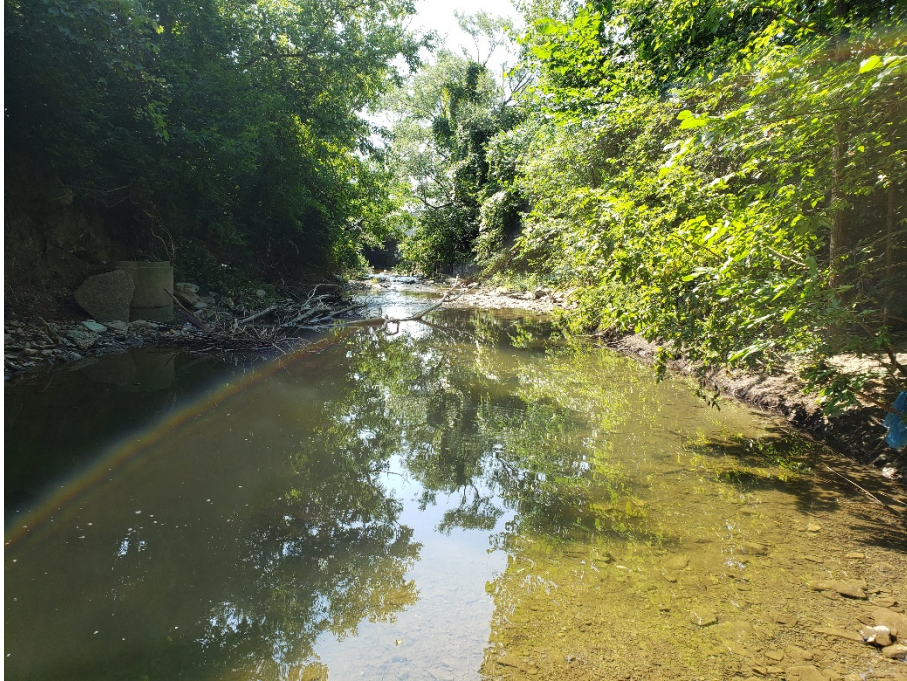
- The existing slopes adjacent to the creek are at approximately 2 horizontal to 1 vertical (2H:1V) from approximately 500 m upstream to 50 m downstream of Dixie Road Bridge; however, steeper slopes were observed along the west bank opposite Willowcreek Park and near vertical slopes were noted along the east bank behind Eddie's Meat Market (approximately 40 m north of Dundas Street East Bridge).

Photograph 21: Looking downstream from behind Eddie's Meat Market.

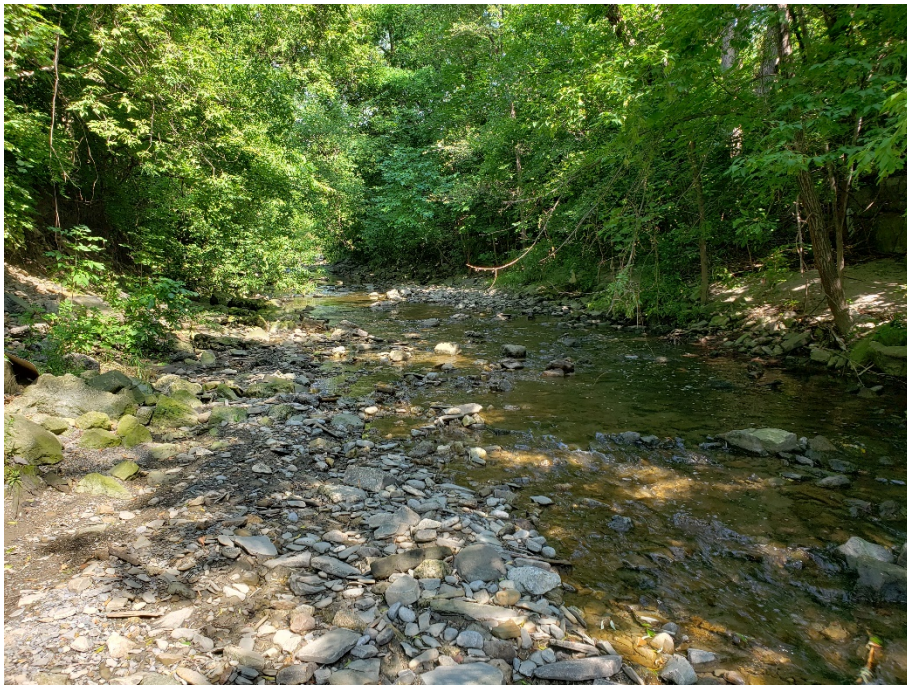
Photograph 22: Looking upstream from behind Eddie's Meat Market.
