SLOPE STABILITY ASSESSMENT

**900 LAKESHORE ROAD WEST,
MISSISSAUGA, ONTARIO, L5H 1H9**

Project No. FG25-15006_V4

Revised March 19, 2026

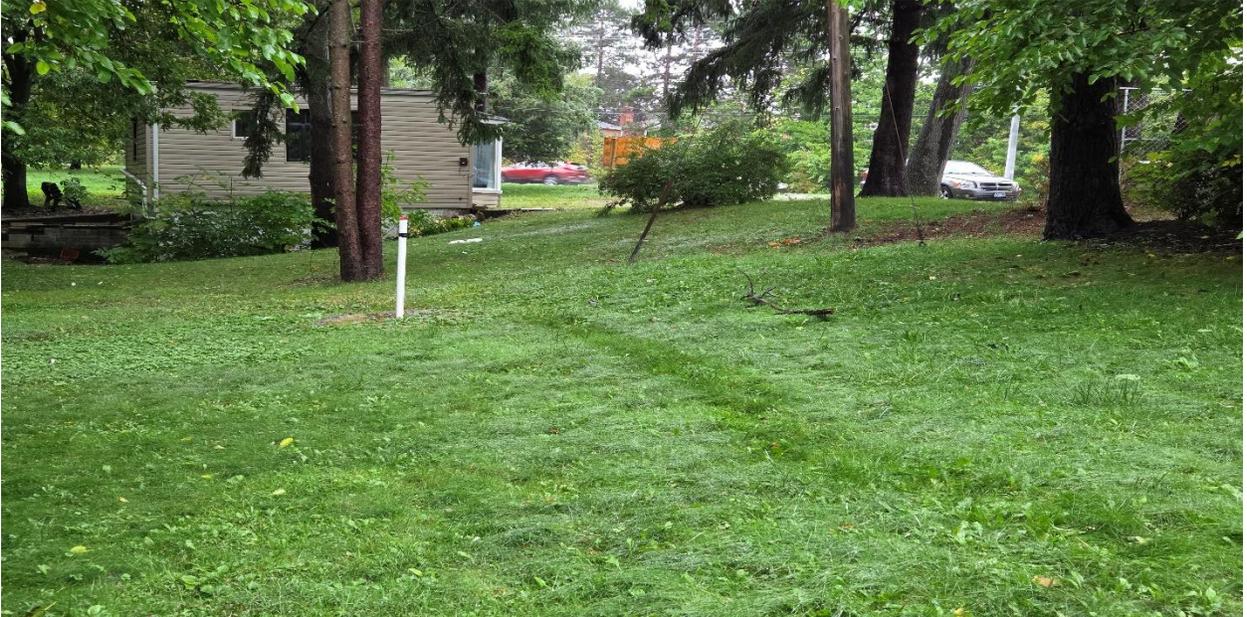
1. Section A-A' looking from east to west

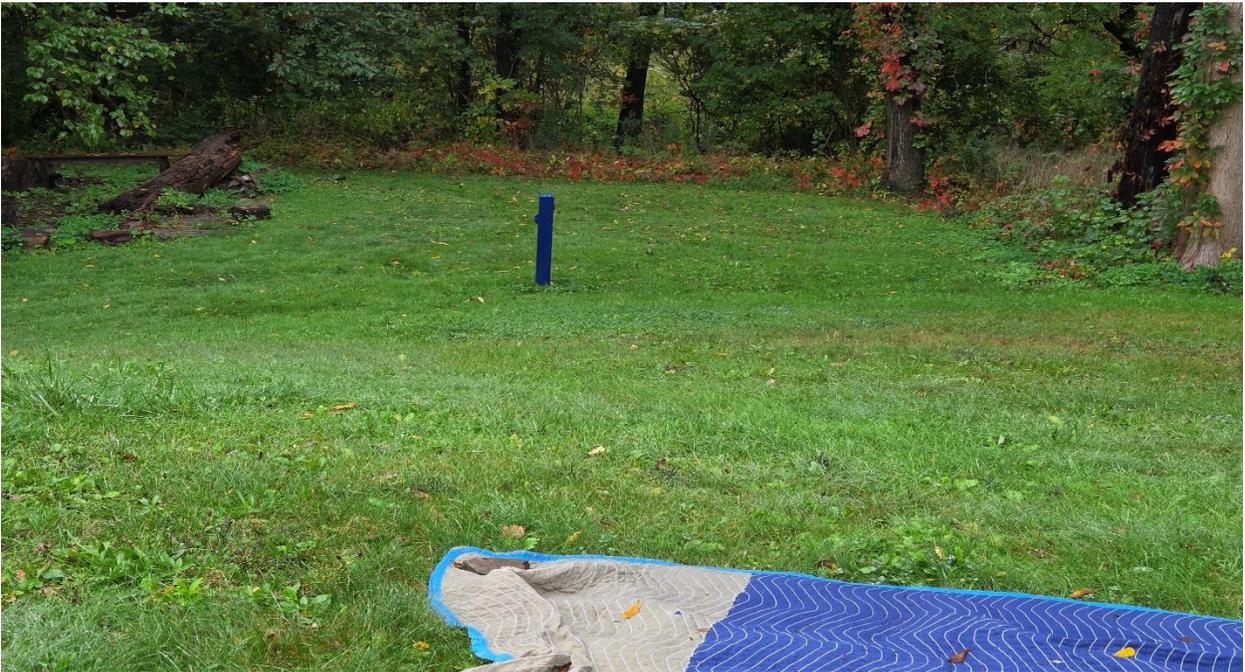
6. Section C-C' looking form north to south

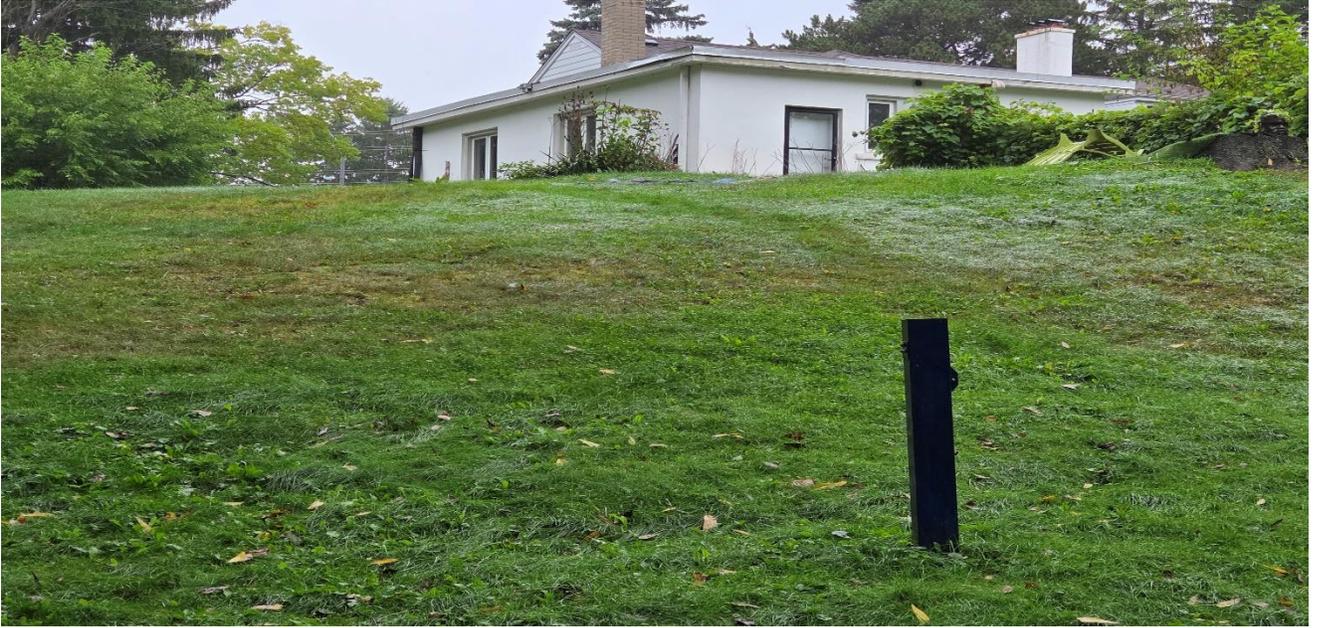
7. Section C-C' looking from east to west

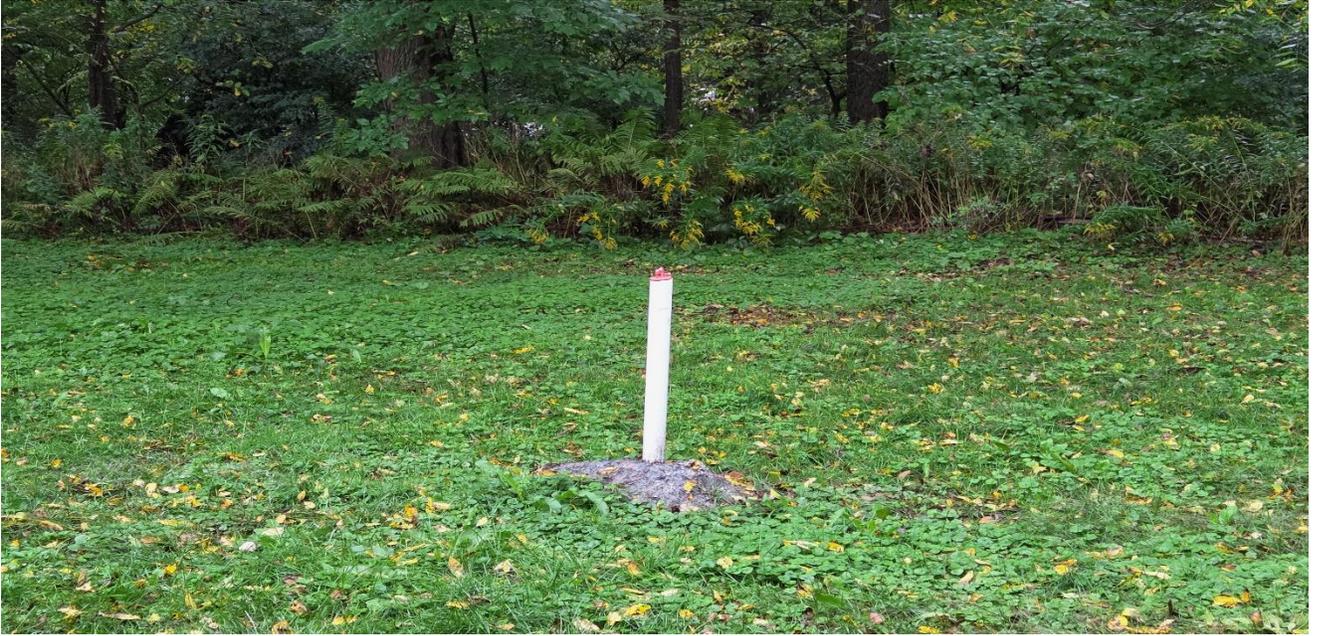
9. Section D-D' looking from west to east

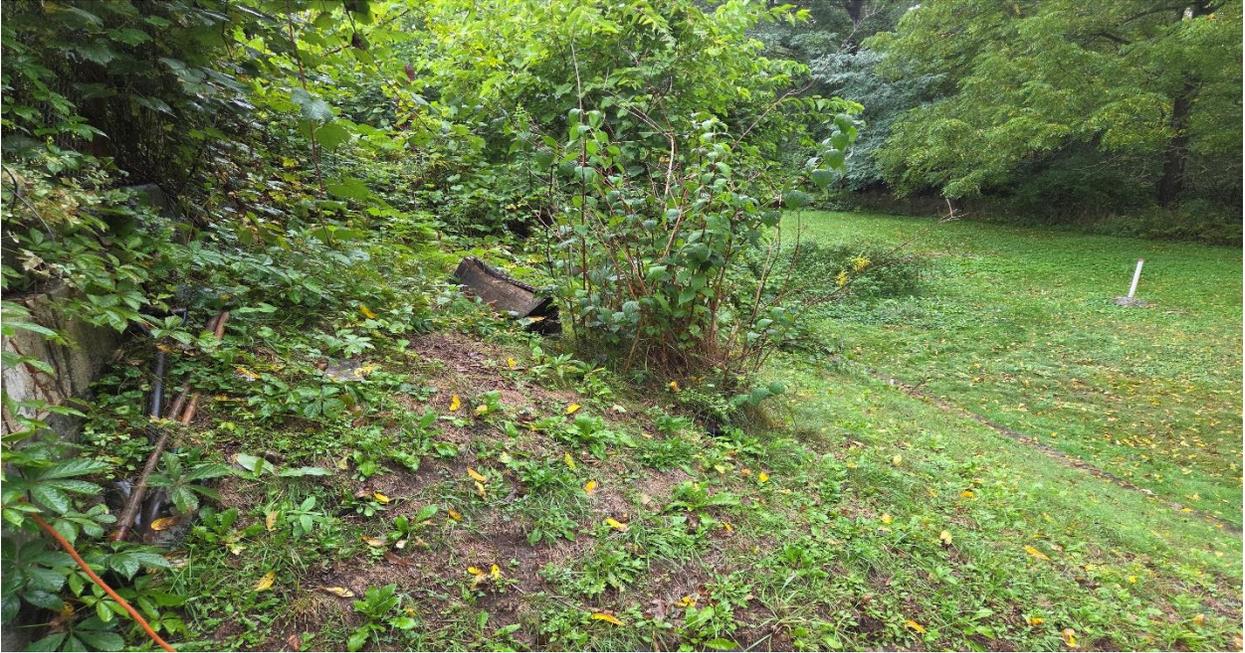
11. Section D-D' looking from south to north

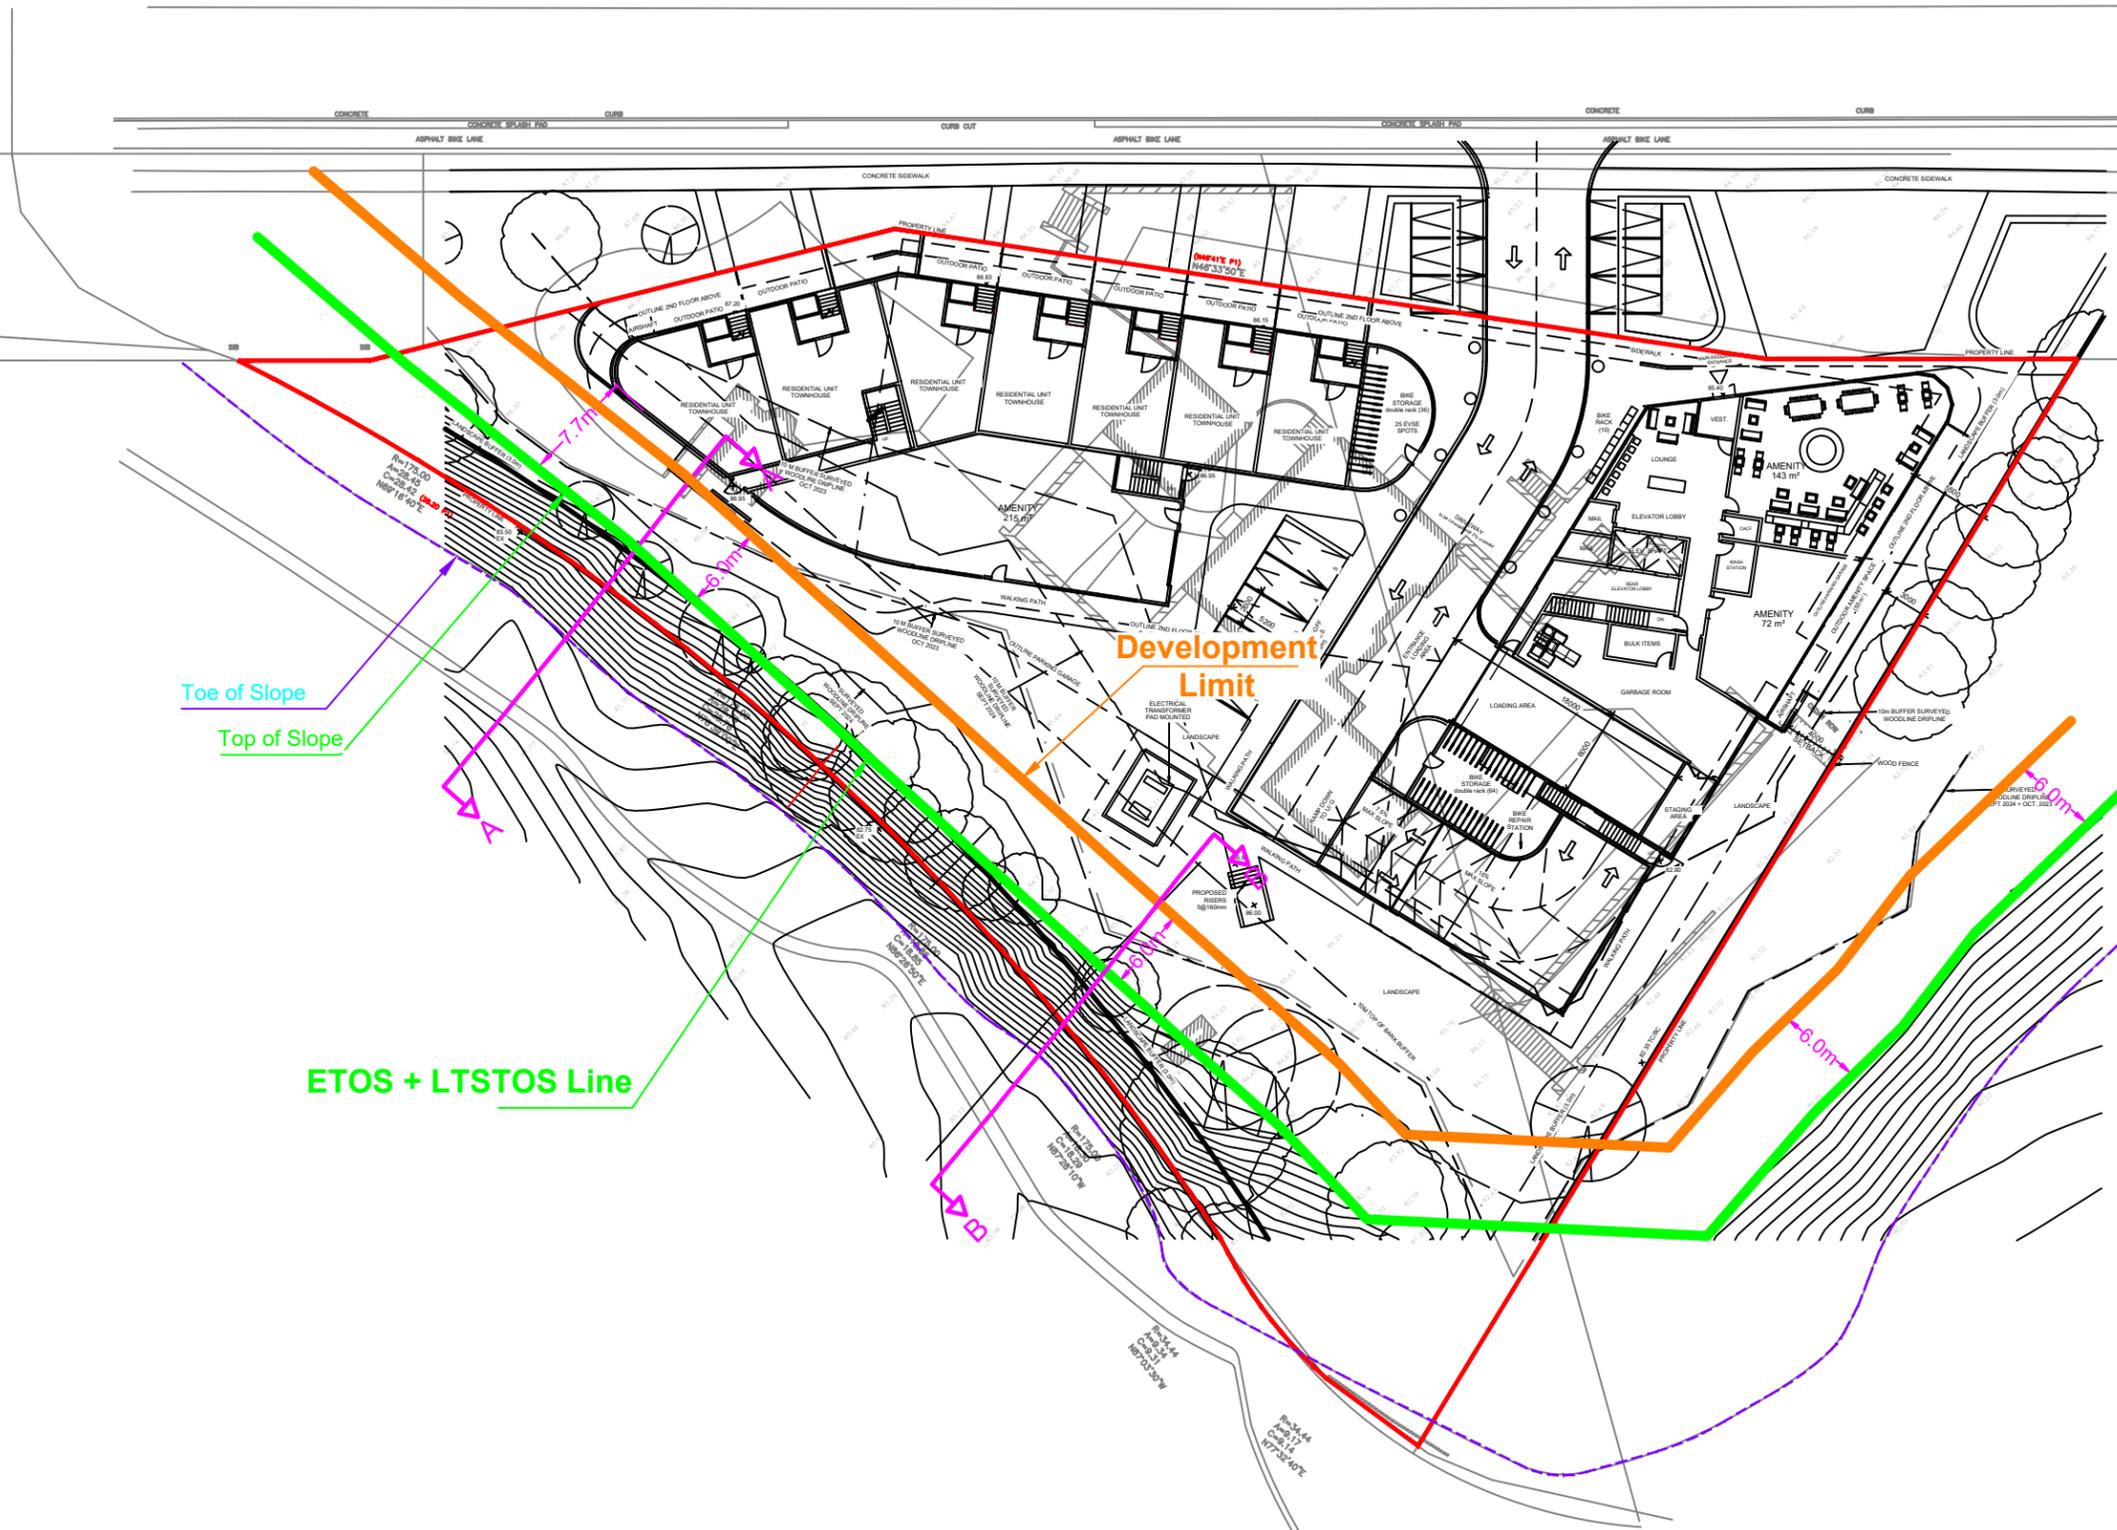
Figure 12

The ETOS line, LTSTOS line and Development Limit line are shown on Site Plan E3 (Figure 12).

Engtec reviewed the site plan E3, the proposed redevelopment would have south edge at 7.7m from the ETOS+LTSTOS line (scenario is illustrated in Figure 10 & 12). The foundation would likely be established at about 3m below the existing grade.

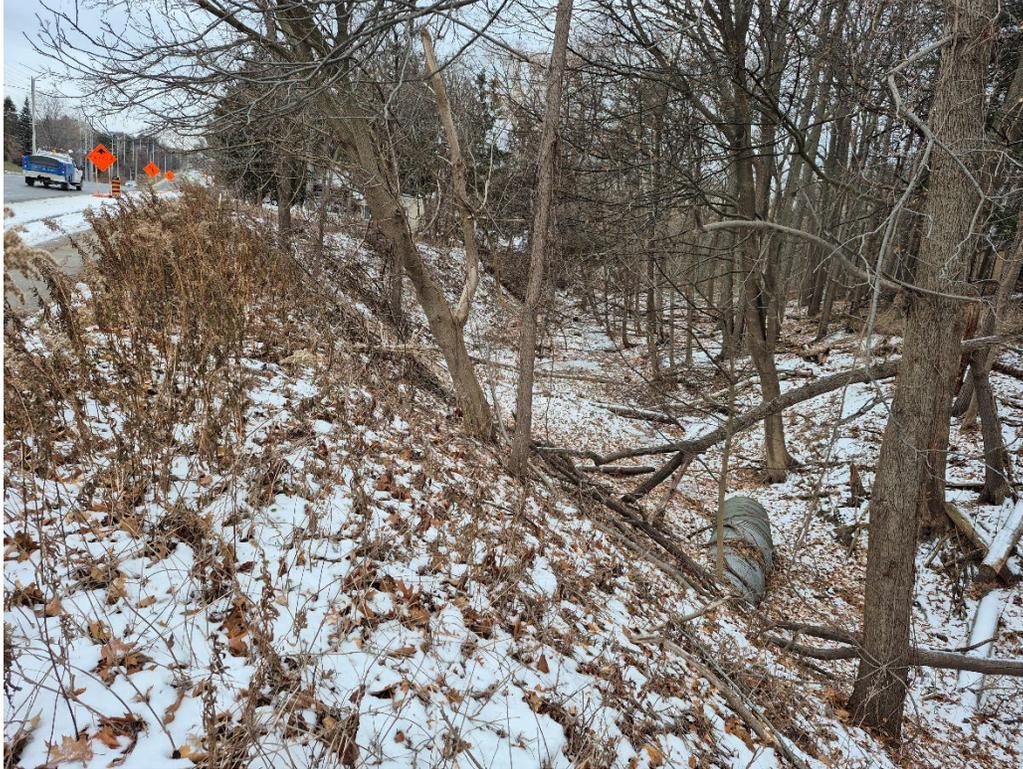
Picture 3: View shows Lakeshore Rd W., Slope Area and Culvert (December 15, 2025).

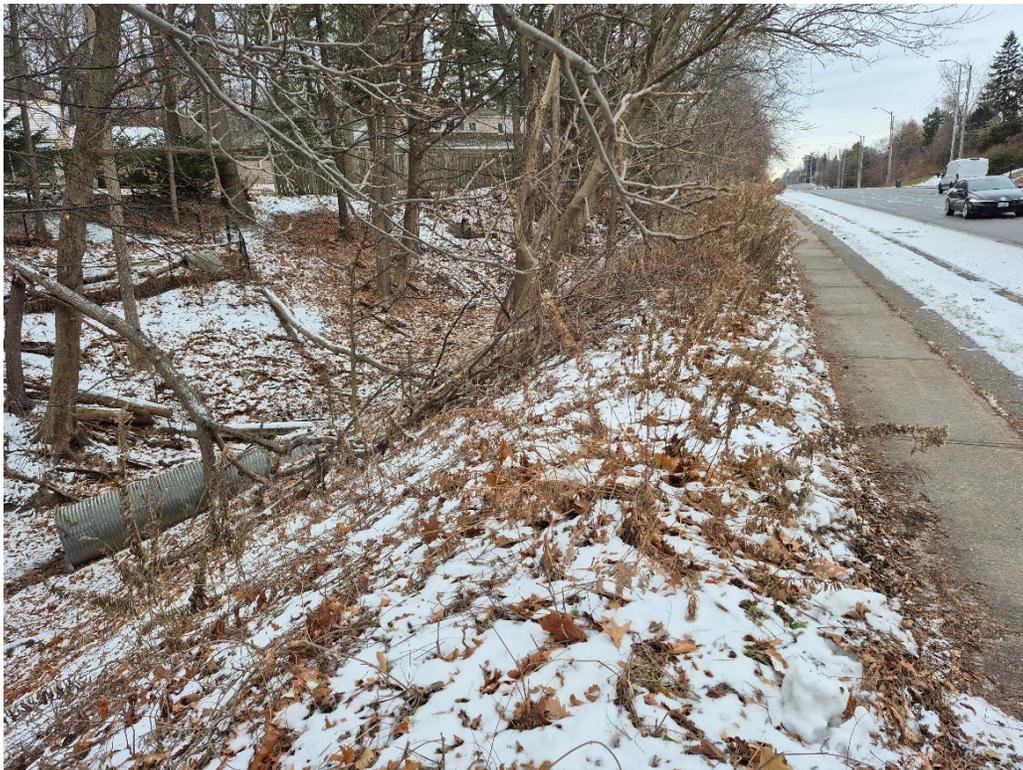
Picture 4: View shows the Culvert underneath the Lakeshore Road West (December 15, 2025)
